# Geotechnical Engineering Report

**Big Flat Road Review**  
**Missoula County, Montana**  
May 17, 2017  
Terracon Project No. C4165060

Re: Geotechnical Engineering Report  
Big Flat Road Review  
Missoula County, Montana  
Terracon Project No. C4165060

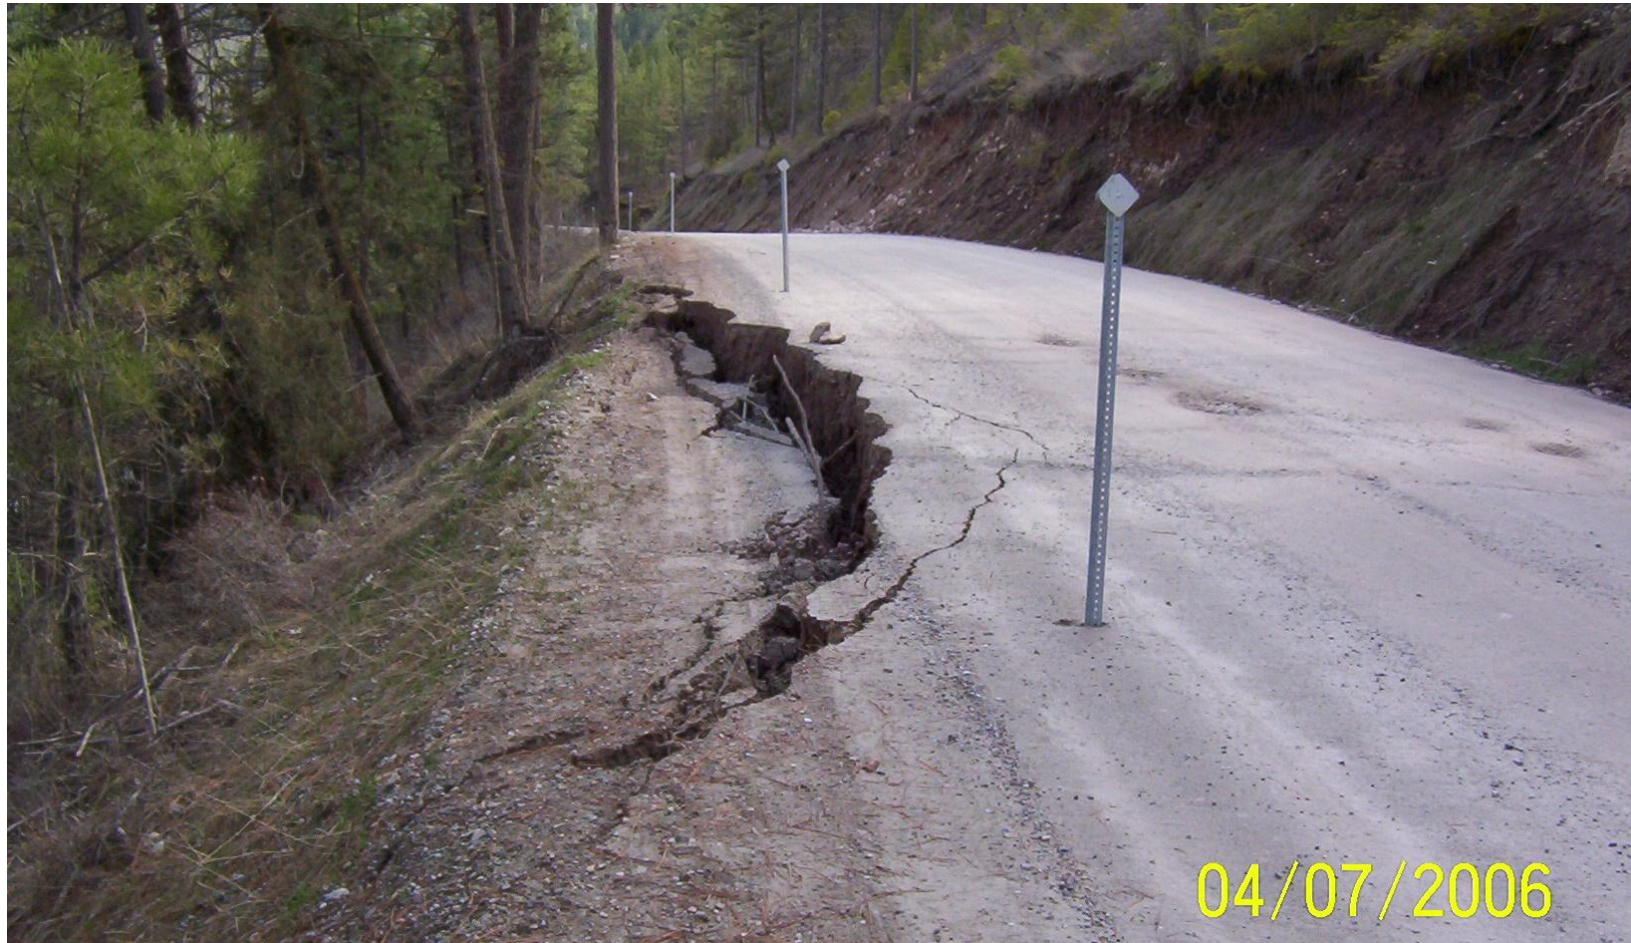
| Project Manager:<br>BJW | Project No.<br>C4165060 | <br>1392 13 <sup>th</sup> Ave SW    Great Falls, Montana 59404<br>PH. (406) 453-5400    FAX. (406) 761-6655 | LANDSLIDE FEATURE AT ZONE 1, APRIL 2006 | Exhibit |

Landslide Zone #1, shown on the attached Exhibits A-3 and A-4, is located on the downhill side of Big Flat Road, about 1,500 feet southeast of the intersection of Big Flat Road and Sherman Creek Road. The overall slide area is about 75 feet in length and 25 feet in height, was first observed in 2006, and movement continues into 2017.

**April 7, 2006 Photo of Landslide Zone #1. The upper edge of the scarp extends approximately 8 feet into the road from the crest of the slope. At this time, the scarp extends about 45 feet along the slope crest. This slide was repaired but would continue to periodically fail, including a March 2017 failure (see Exhibit A-4)**

Repair of Landslide Zone #1 could be accomplished using either side hill grading or RSS techniques. Based on the assumption that the least-cost (Side Hill Grading) approach could be employed, repair of this landslide segment would cost, at a minimum, \$37,500.00. This cost assumes that the landslide area has not increased since the site was observed earlier this year, and that the Side Hill Grading approach was deemed acceptable based on a site-specific geotechnical study. Even using the Side Hill Grading approach, it is likely that at least half of the roadway width would have to be closed to accommodate the excavation required to support the subject construction.

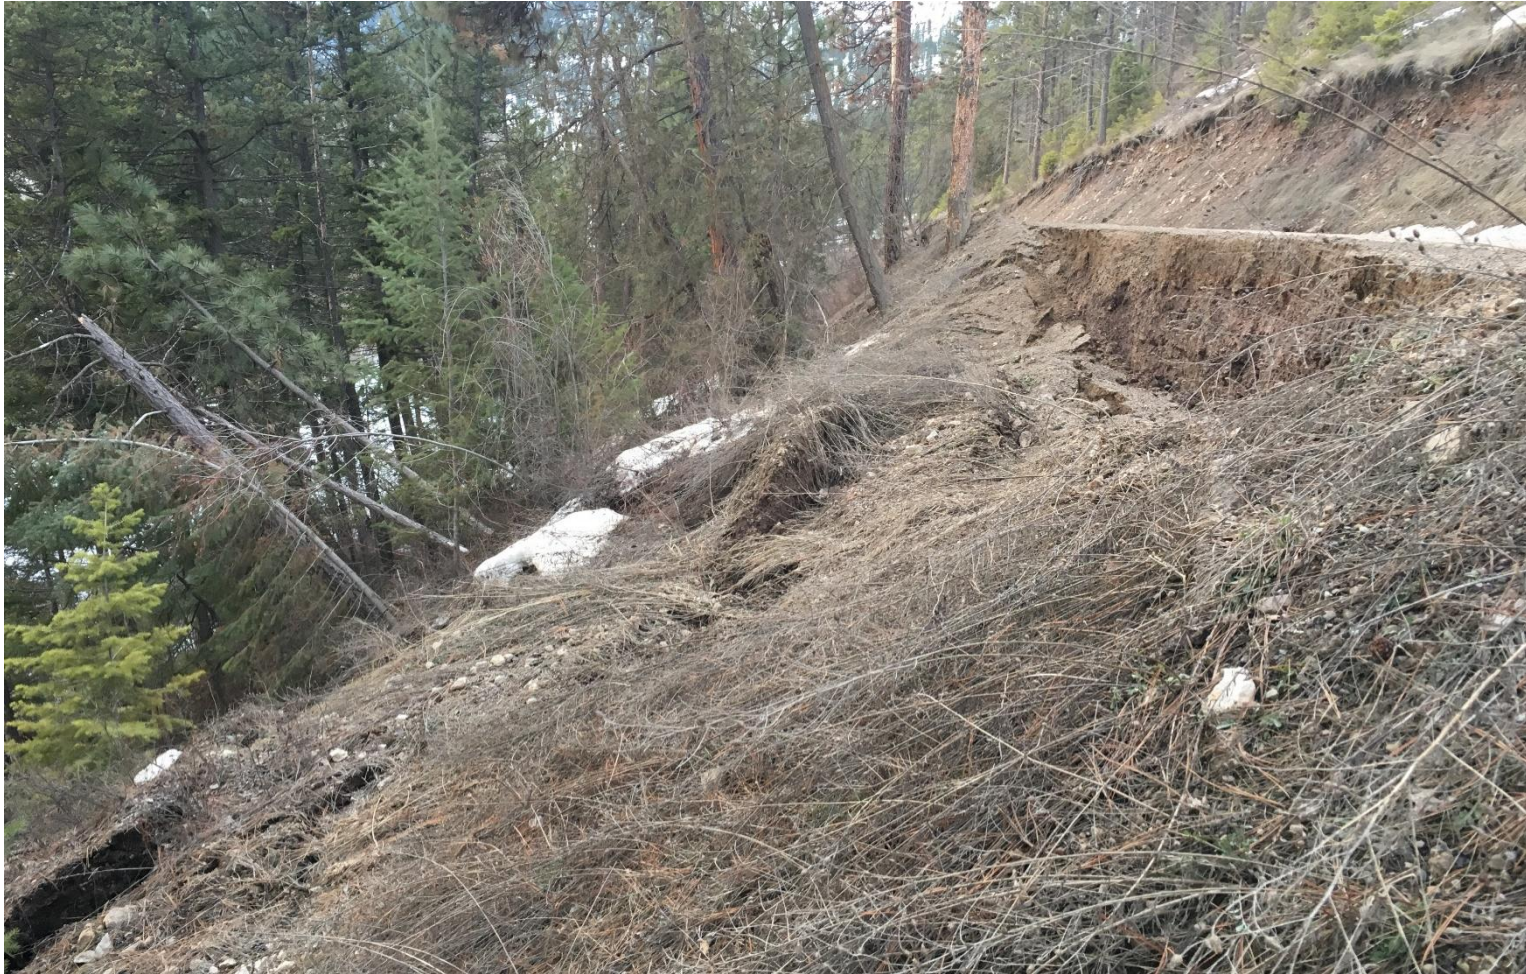
| Project Manager:<br>BJW | Project No.<br>C4165060 | <br><br>1392 13 <sup>th</sup> Ave SW      Great Falls, Montana 59404<br>PH. (406) 453-5400      FAX. (406) 761-6655 | LANDSLIDE FEATURE AT ZONE 1, MARCH 2017 | Exhibit |

**March 13, 2017 landslide failure at Zone 1, Big Flat Road. Despite previous repairs, the downslope area at and adjacent to Zone 1 failed again in March 2017. The cleared area in the foreground (absent of trees) is the re-graded surface of previous landslides and repairs. The tilted trees shown in the near background are part of the current landslide mass, but many “stable” areas along Big Flat Road exhibit similar tilting trees as the slope creeps but prior to full-scale landsliding.**

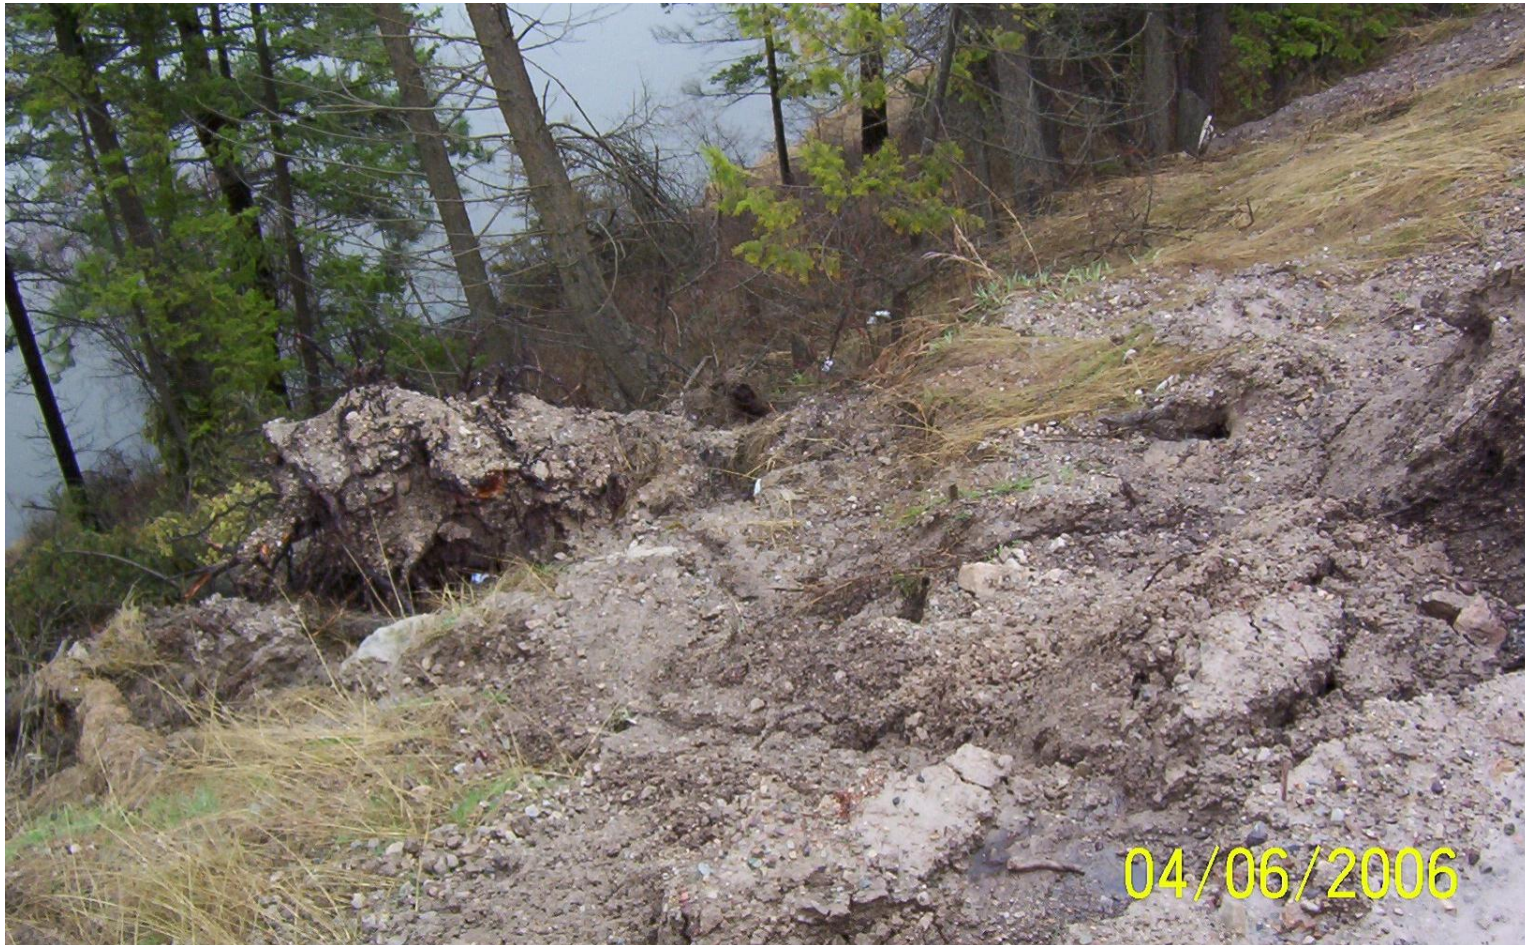
| Project Manager:<br>BJW | Project No.<br>C4165060 | <br><br>1392 13 <sup>th</sup> Ave SW      Great Falls, Montana 59404<br>PH. (406) 453-5400      FAX. (406) 761-6655 | LANDSLIDE FEATURE AT ZONE 2, APRIL 2006 | Exhibit |

Landslide Zone #2 is located on the downhill side of Big Flat Road, adjacent to the intersection of Big Flat Road and Sherman Creek Road. The overall slide area is about 80 feet in length and about 35 feet in height. This landslide was first observed in 2006, and movement continues into 2017.

Shown here is the downhill extent of a landslide that extends about 80 feet along the outside (downhill) edge of Big Flat Road, just to the right of the intersection with Sherman Gulch Road (see exhibit A-2). The slide here is about 35 feet tall, and is primarily an infinite slope failure, although there is an arcuate component to the slide base near the top of the landslide. Note, too, the tilting trees downhill and outside of the current slide mass.

Our review indicates that, although landslide Zone #2 could possibly be repaired using only the Side Hill Grading approach, it is likely that either the RSS or MSE wall approach would have to be employed to accommodate the height of this landslide. In addition, like the repair work at Landslide Zone #1, it is likely that at least half of the roadway width would have to be closed to accommodate the construction here. Costs associated with repair of this landslide could range from \$56,000.00 to \$112,000.00, assuming that the area of this landslide has not increased since our observations of earlier this year.

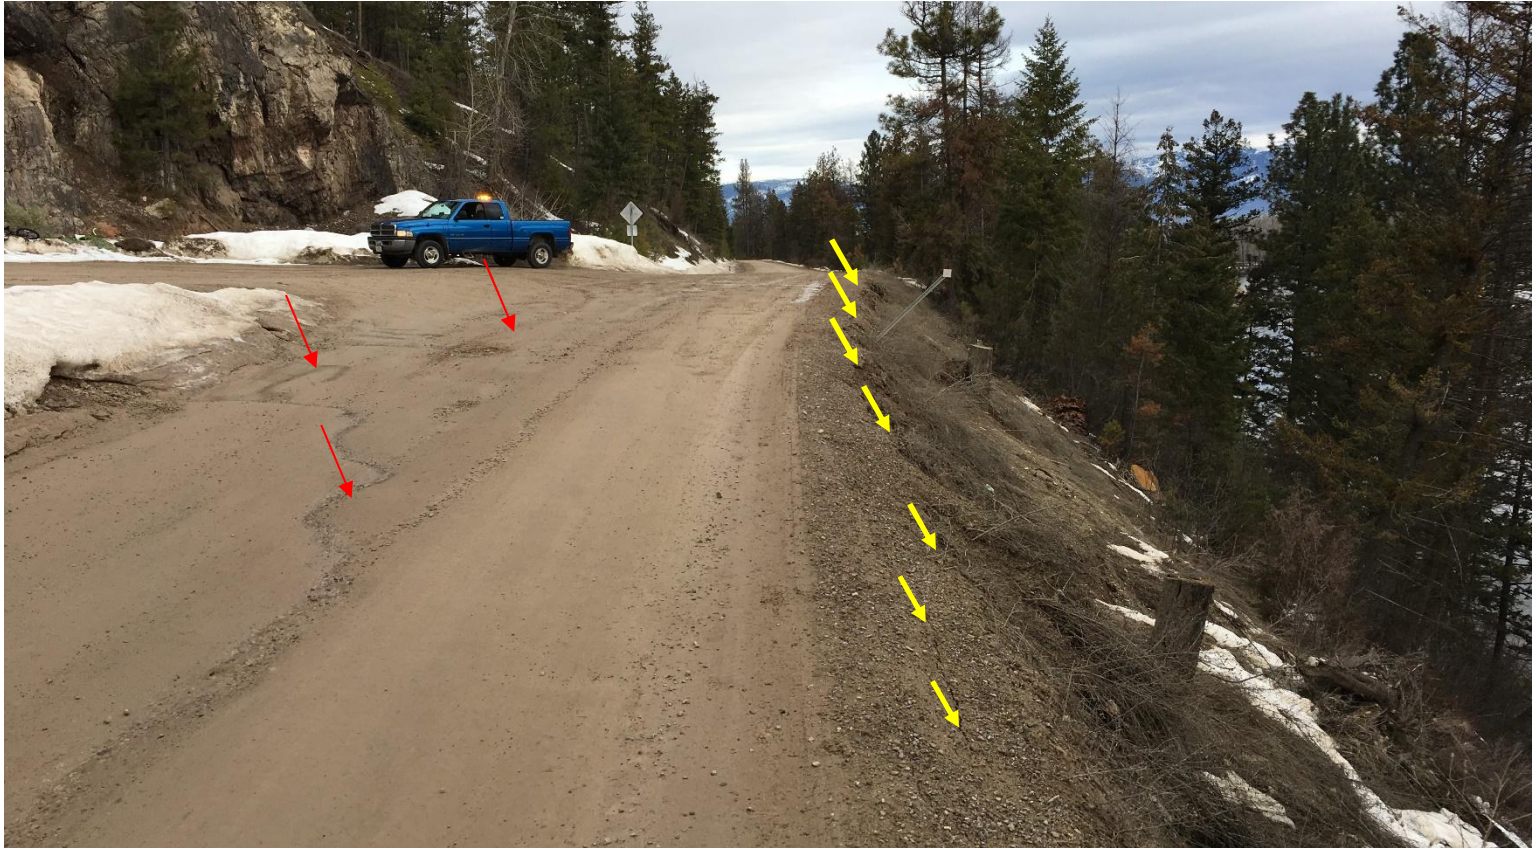
| Project Manager:<br>BJW | Project No.<br>C4165060 | <br><br>1392 13 <sup>th</sup> Ave SW      Great Falls, Montana 59404<br>PH. (406) 453-5400      FAX. (406) 761-6655 | LANDSLIDE FEATURE AT ZONE 2, MARCH 2017 | Exhibit |

**Photo of the Zone 2 Big Flat Road Landslide on March 13, 2017. The 2017 landslide crest is delineated by the yellow arrows, and an older scarp, not well developed but in the roadway, is shown by the red arrows. The 2017 slide did not develop to the extent of earlier slide episodes, but did undergo movement nonetheless.**

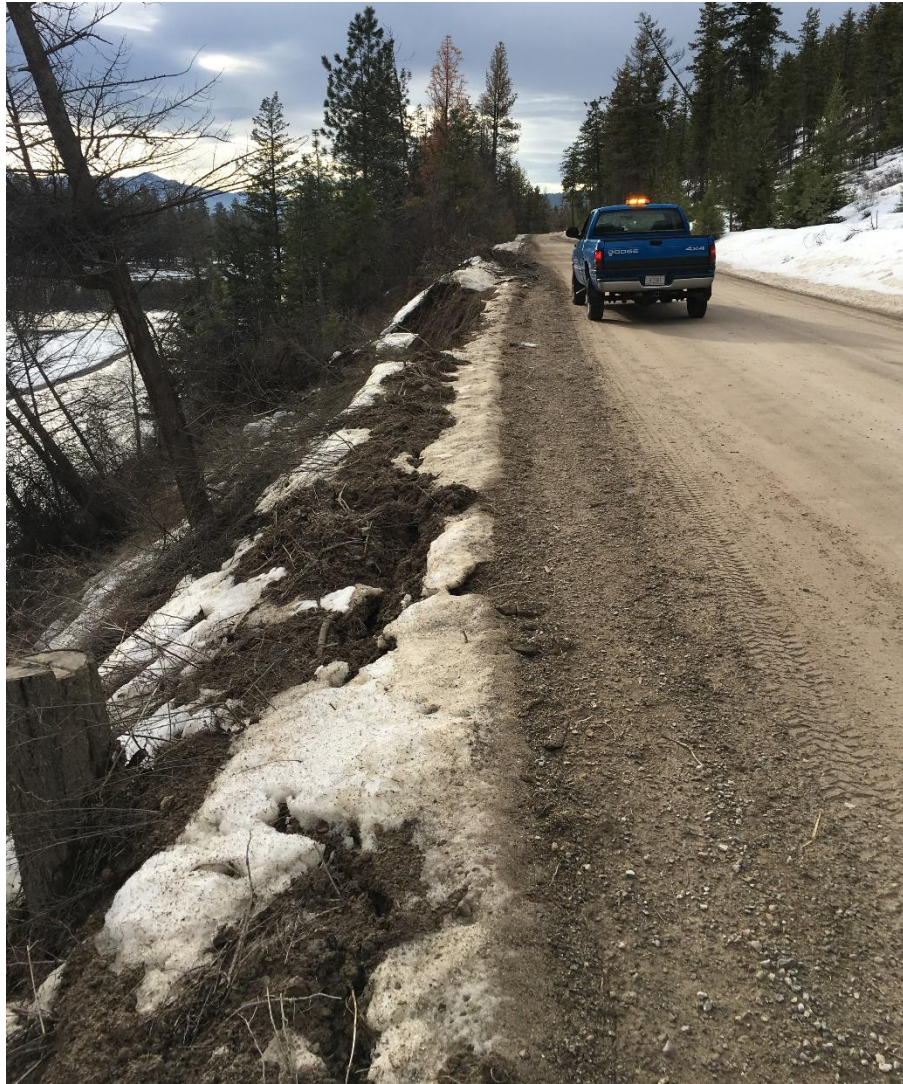
| Project Manager:<br>BJW | Project No.<br>C4165060 | <br>1392 13 <sup>th</sup> Ave SW    Great Falls, Montana 59404<br>PH. (406) 453-5400    FAX. (406) 761-6655 | LANDSLIDE FEATURE AT ZONE 3, MARCH 2017 | Exhibit |

Landslide Zone #3 is located on the downhill side of Big Flat Road, about 1,500 feet northwest of the intersection of Big Flat Road and Sherman Creek Road, as shown on the attached Exhibit A-7. This landslide is about 115 feet in length and about 50 feet in height. According to reports from the County, Landslide #3 was first observed in 2017. Like many of the other landslides along this reach, the scarp that remains along the road following the initial slide movement is nearly vertical; and although the scarp may remain inactive for several years, a steep scarp such as this one will be in a state of imminent slope failure more so than the original slope, potentially precipitating landslide growth that would extend further across the road in the next slide episode.

This landslide is relatively large but is relatively shallow, with a total active height on the order of 50 feet but with a depth of only about 5 to 10 feet parallel to the slope surface. This landslide extends from the roadway almost down to the Clark Fork River. Such failure height limits repair alternatives, since the existing slope grade is at or near the angle of repose, meaning that the current slope angle is only marginally stable as-is. On that basis, the Side hill Grading approach may not be suitable for repair of this landslide because the repairs would have to extend to or near the Clark Fork River, potentially triggering a lengthy and costly permitting process. On that basis, a reinforced approach (such as an RSS slope or an MSE or Crib/Bin wall approach that terminates at least 20 feet above river elevation) would likely have to be adopted, based on the outcome of a site-specific geotechnical study. Repair costs for this landslide segment could range from a minimum of about \$103,500.00 to \$189,750.00, or possibly more, depending on the outcome of the site-specific geotechnical study. We should note here that repair of this road segment would likely require full-width road closure to accommodate the excavation necessary to accomplish the necessary construction of this landslide segment.

This photograph shows a slide that first exhibited movement in 2017. Designated as Landslide Zone #3, this slide is a relatively shallow infinite slope (“skin slide”) that, while less than about 5 to 10 feet in thickness normal to the slope, extends more than 110 feet along the road, and extends almost down to the Clark Fork River at the left of this scene, a height of about 50 feet. Like many of the other landslides along this reach, the scarp that remains along the road is nearly vertical. Although the scarp may remain so for several years, a steep scarp such as this one (and the scarp downhill of most of Landslide Zone #4) has a much lower factor of safety against additional slope failure than the original steep slope face that just failed here.

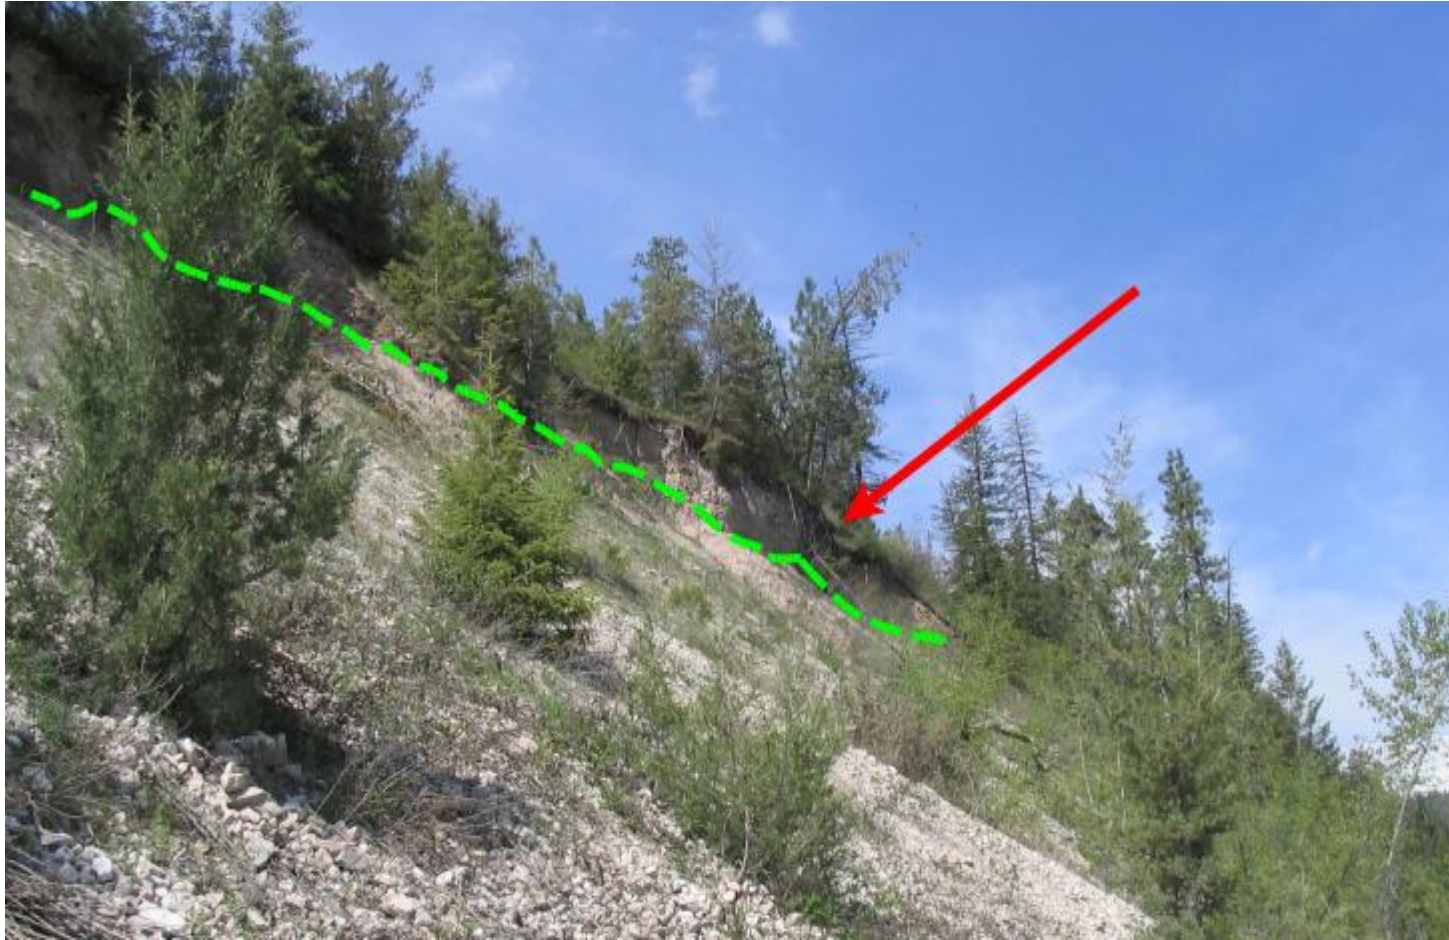
| Project Manager:<br>BJW | Project No.<br>C4165060 | | LANDSLIDE FEATURE #1 AT ZONE 4, MAY, 2005 | Exhibit |

Image of Landsliding at Zone 4 location (Exhibit A-2). This photo was taken May 13, 2005, and exhibits a view of Big Flat Road from the old road alignment downhill of the current Big Flat Road alignment. The dashed green line separates a layer of moderately cemented gravel (above the dashed green line) from a layer of interbedded glacial lacustrine silt/clay below the dashed green line. As the glacial lacustrine soils erode on the face of the slope, the upper gravel layer is undermined and then fails along a near vertical face. At this location, the Big Flat Road alignment is less than 15 feet back from the crest of the hill (shown by the red arrow).

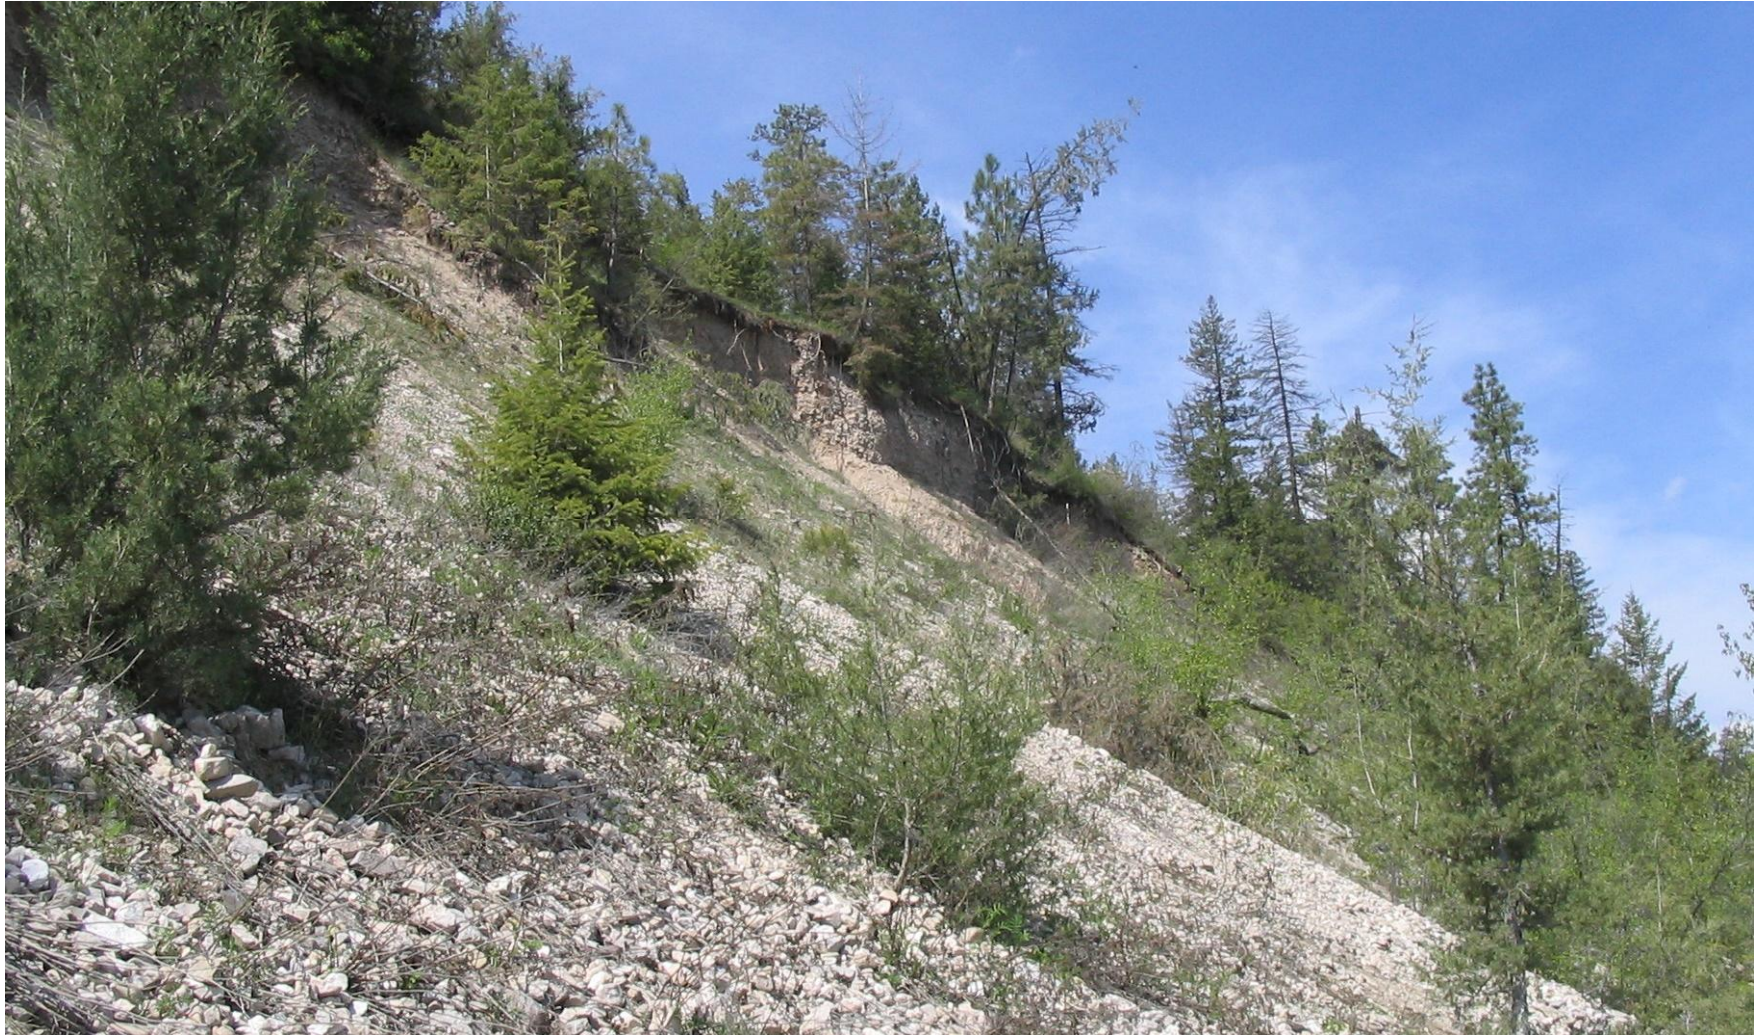
| Project Manager:<br>BJW | Project No.<br>C4165060 | | LANDSLIDE FEATURE #2 AT ZONE 4, MAY, 2005 | Exhibit |

Enlargement of photo from Exhibit A-8. The foreground is landslide debris from the uphill propagation of landsliding from the old road alignment below, from which this photo was taken. Note that the vertical face at the crest of the old landslide is less than 15 feet away from the edge of the current Big Flat Road alignment. Note also the downhill-tilting trees atop the remnant soil block above the cliff face.

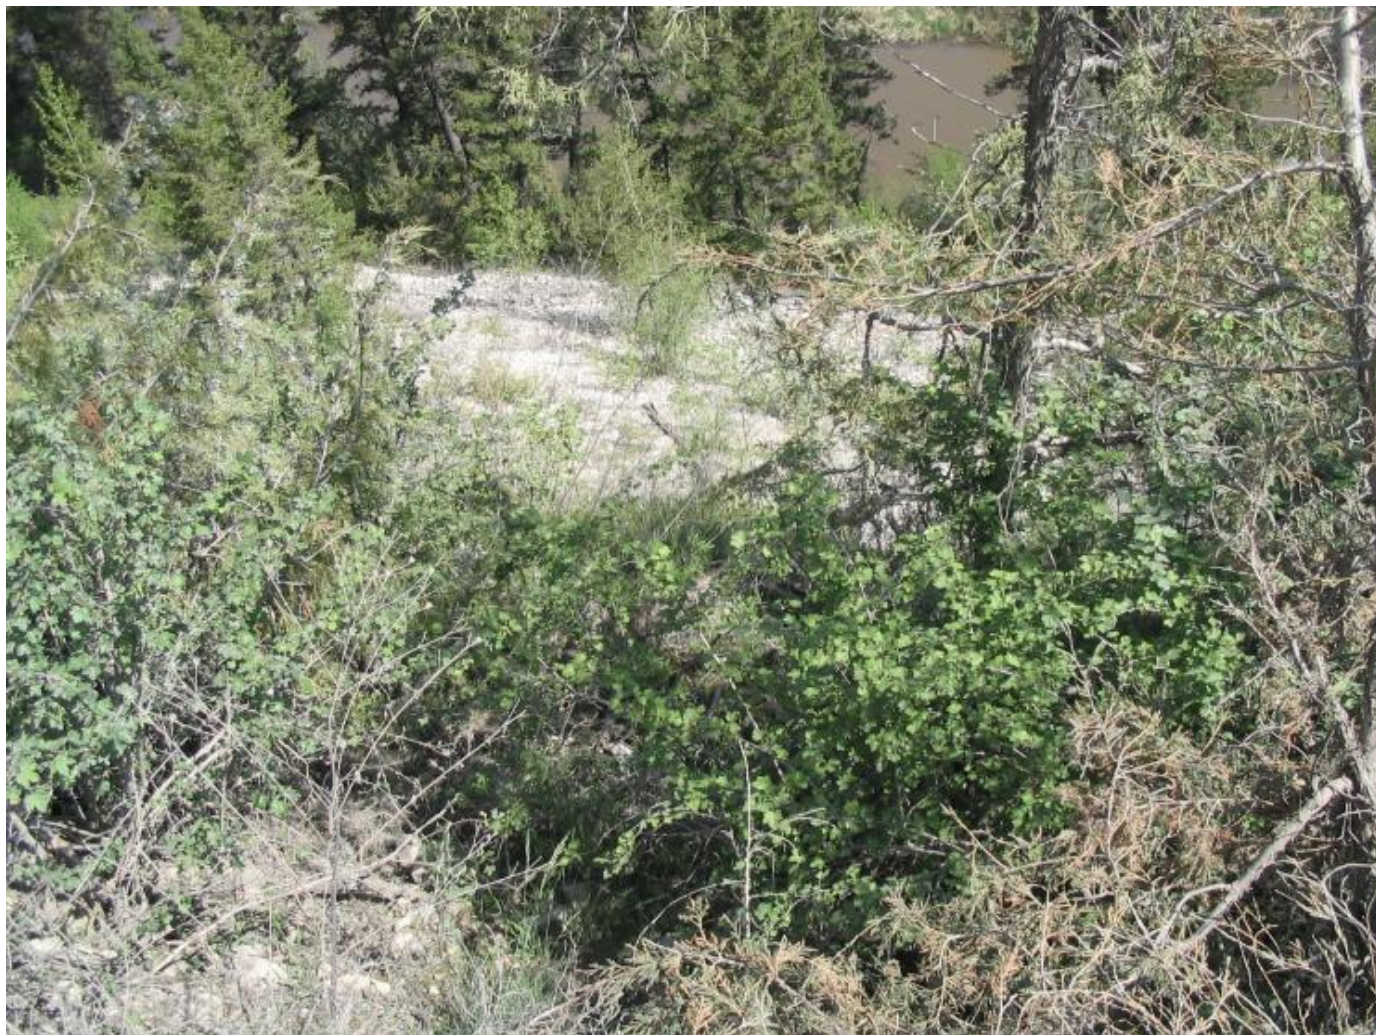
| Project Manager:<br>BJW | Project No.<br>C4175060 | <br>1392 13 <sup>th</sup> Ave SW    Great Falls, Montana 59404<br>PH. (406) 453-5400    FAX. (406) 761-6655 | LANDSLIDE FEATURE #3 AT ZONE 4, MAY 2005 | Exhibit |

Image of Landsliding at Zone 4 location (Exhibit A-2). This photo was taken May 13, 2005, and shows a view of the same landslide zone shown on the previous Exhibit A-8, except that this photo is taken from uphill of the slide zone looking down from the edge of the road. Note that the crest of the landslide is about 15 feet from the edge of the road.

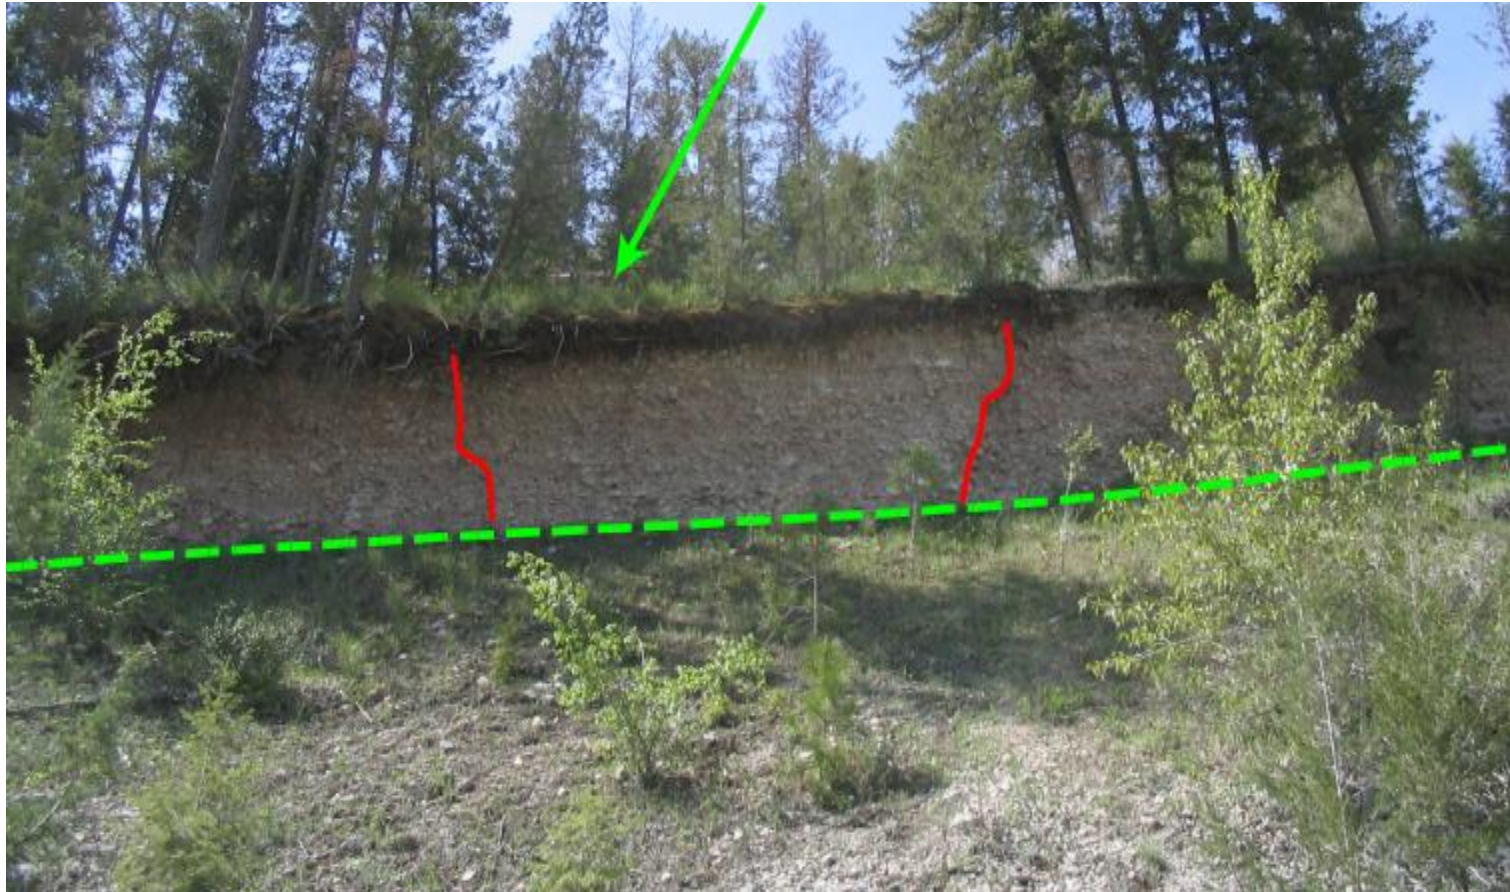
| Project Manager:<br>BJW | Project No.<br>C4175060 | <br>1392 13 <sup>th</sup> Ave SW    Great Falls, Montana 59404<br>PH. (406) 453-5400    FAX. (406) 761-6655 | LANDSLIDE FEATURE #4 AT ZONE 4, MAY 2005 | Exhibit |

Image of Landsliding at Zone 4 location (Exhibit A-2). This photo was taken May 13, 2005, and shows a view near the southeast end of the slide area from the old road alignment below. Like Exhibit A-8, the cemented gravel layer is shown above the dashed line and glacial lacustrine clay is shown below the dashed line. Also shown is an overhanging layer of organic detritus beneath which part of the gravel layer has already failed. At this location, the outside edge of the road is less than 10 feet from the crest of the slide, and the cab of a log hauling truck (noted by the green arrow, heading downhill) is observed directly above the slope crest from the aspect of this photo. Also observed are two cracks in the gravel layer (denoted by the red traces). At this location, the cracks in the gravel layer indicate a section of gravel where sloughing failure is imminent.

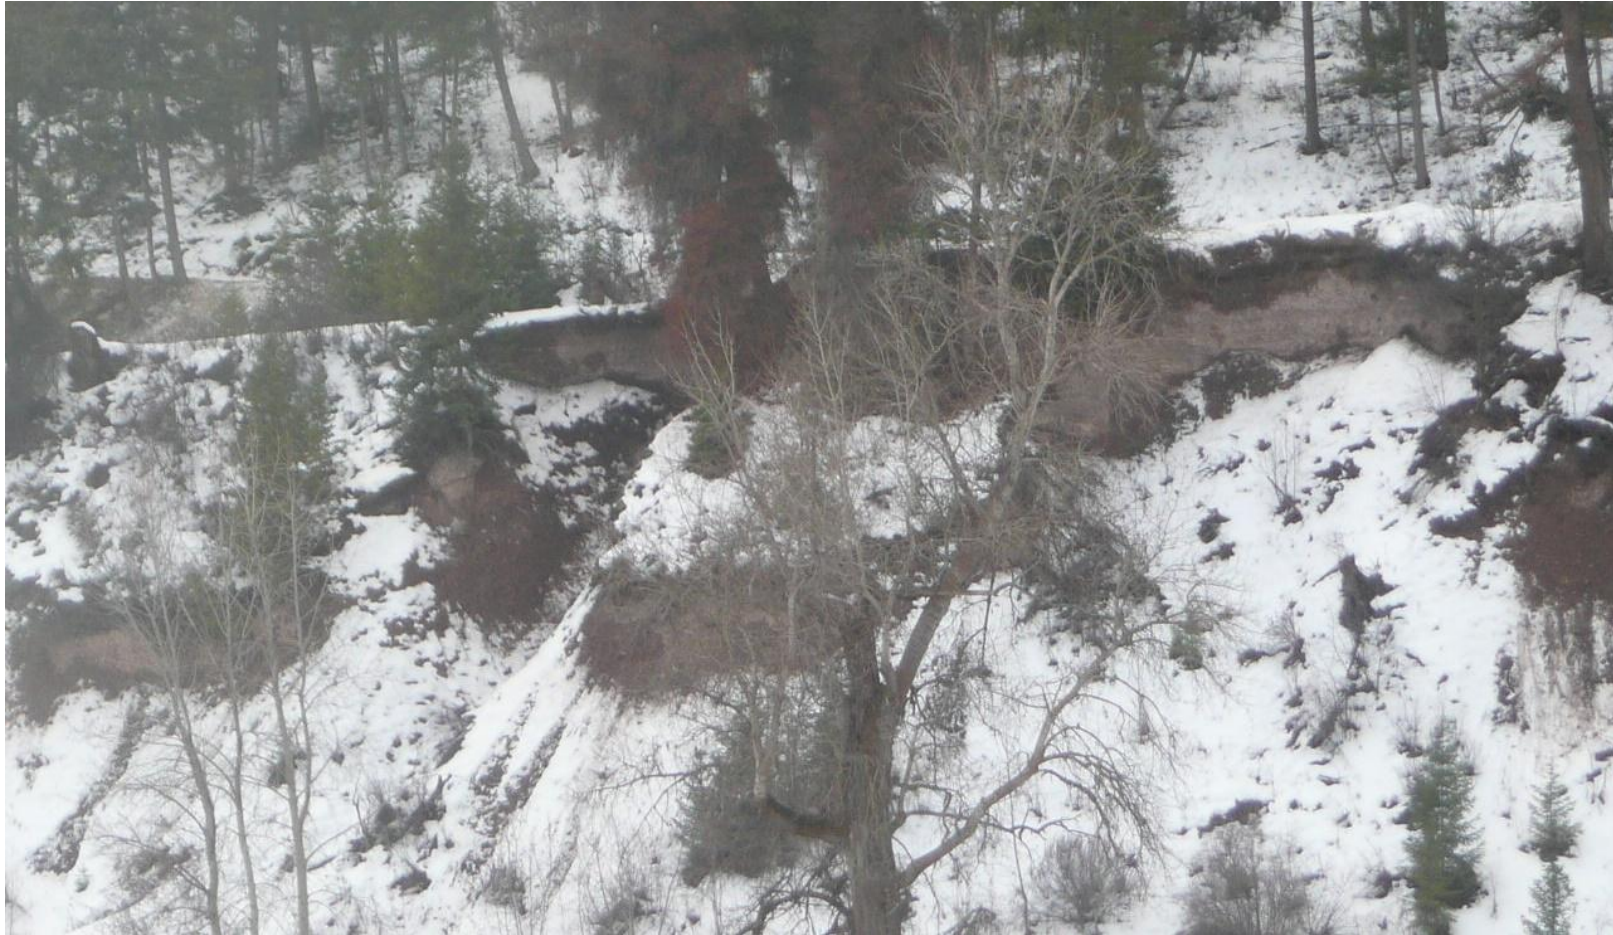
| Project Manager:<br>BJW | Project No.<br>C4175060 | <br>1392 13 <sup>th</sup> Ave SW    Great Falls, Montana 59404<br>PH. (406) 453-5400    FAX. (406) 761-6655 | LANDSLIDE FEATURE AT ZONE 4, JANUARY 2015 | Exhibit |

This photograph shows a landslide within Zone #4, just to the northwest of the series of images shown on the previous Exhibits A-8, A-9, and A-10. This landslide is relatively small compared to the overall size of the Zone #4 landslide, but is another example of the start of a larger landslide that could remove the entire width of roadway from service, and which would require extensive and expensive repair to stabilize the road and allow traffic back on the alignment.

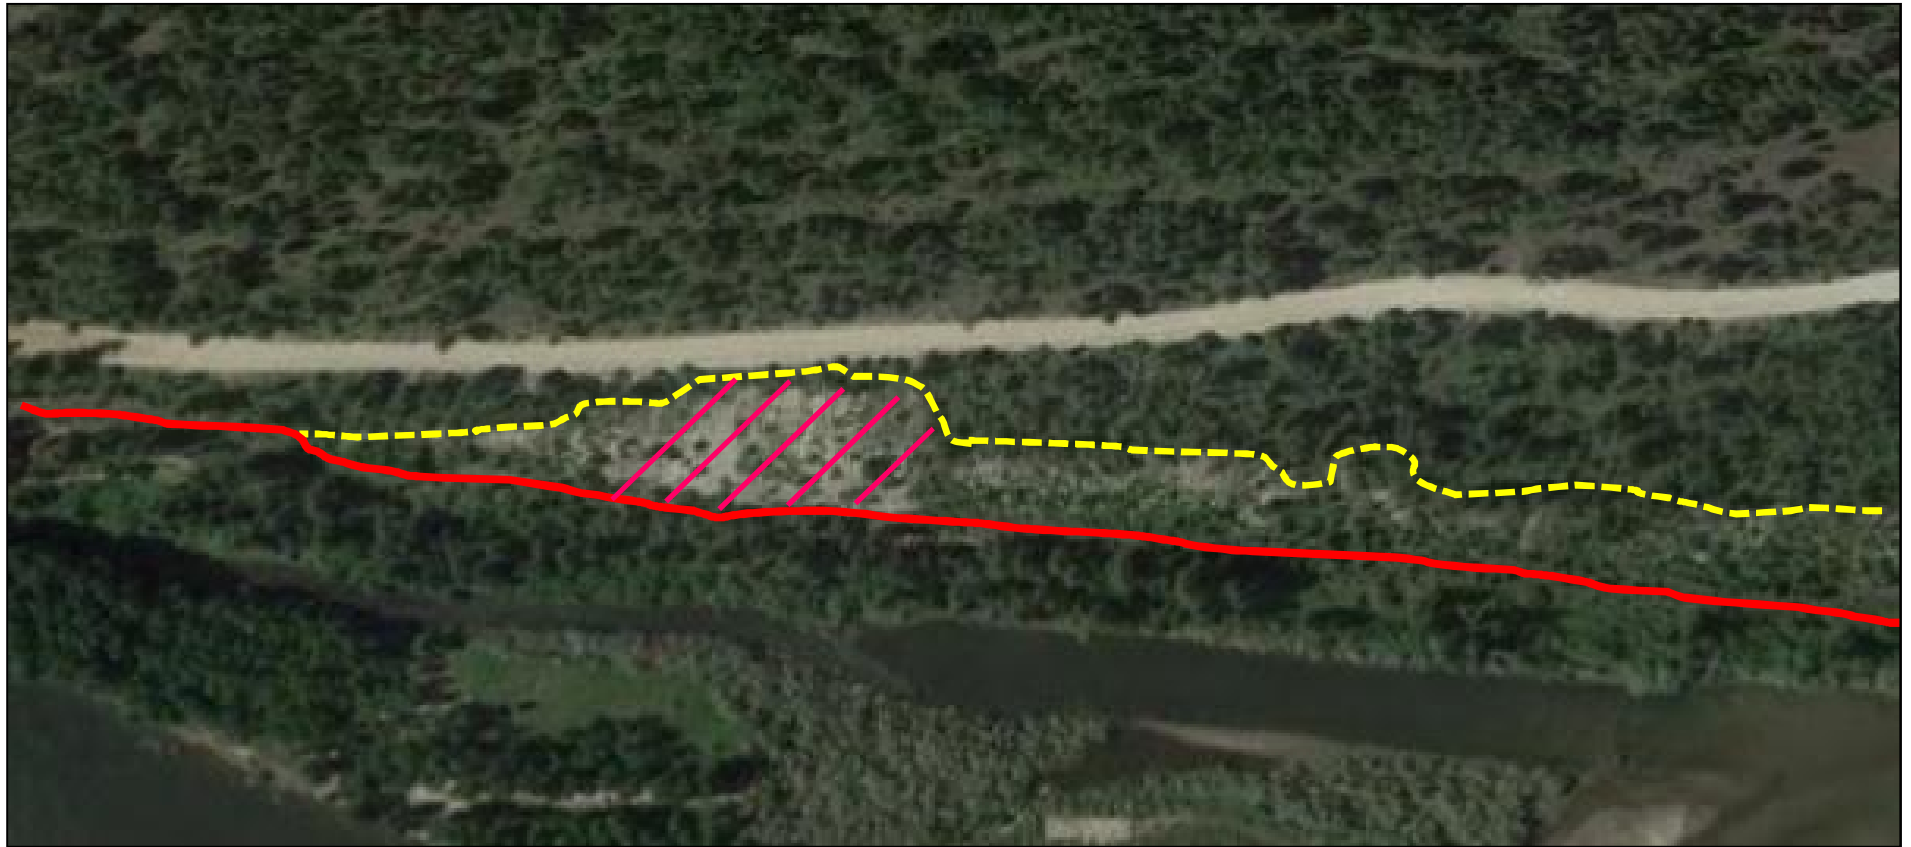
| Project Manager:<br>BJW | Project No.<br>C4165060 | <br><br>1392 13 <sup>th</sup> Ave SW      Great Falls, Montana 59404<br>PH. (406) 453-5400      FAX. (406) 761-6655 | LANDSLIDE FEATURE #5 AT ZONE 4 | Exhibit |

Oblique view of the southeast segment of the #4 Landslide Zone. The current Big Flat Road alignment is seen as the gray line at the middle of the scene, and the red line follows a former Big Flat Road alignment. The lower alignment (the red line) was constructed by cutting into the toe of the slope without any effort at slope stabilization. Over time, the cut slope above the red line progressively failed uphill, with the landslide debris covering the lower alignment and causing the road alignment to be shifted uphill to its current location. The current landslide issue is that the landslides initiated by the old road construction are now impacting the current alignment, having caused certain areas (like the pink-hachured zone above) to cause landsliding over the entire slope above the old road and below the new road.

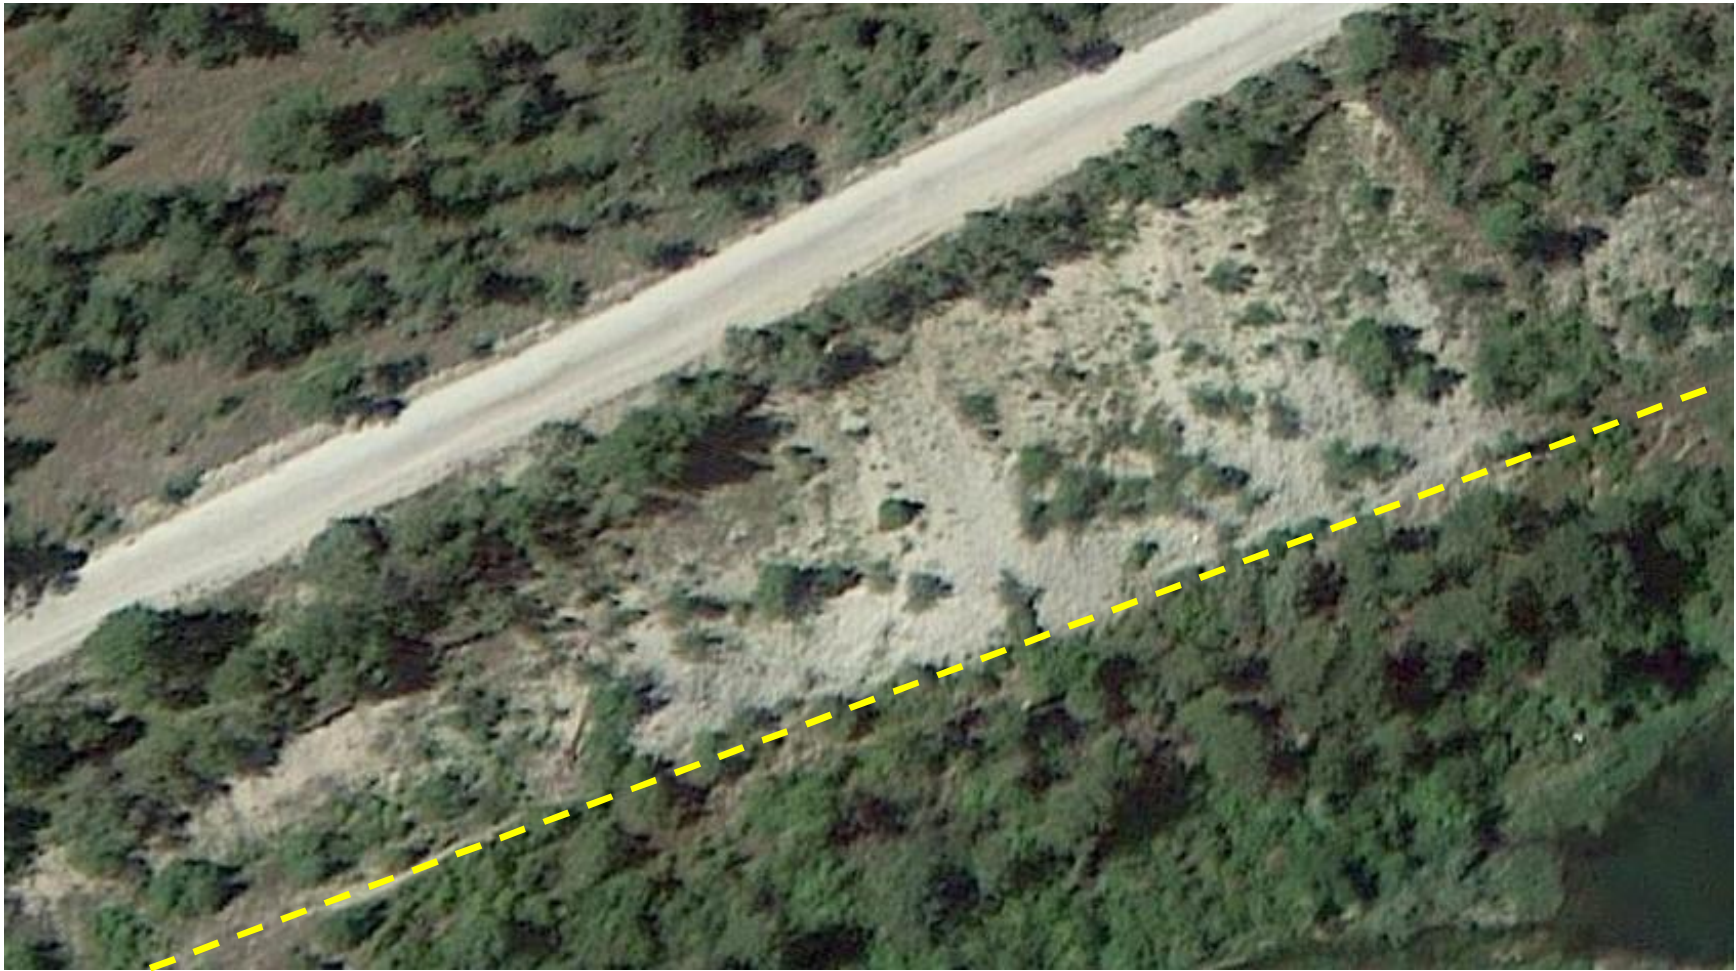
| Project Manager:<br>BJW | Project No.<br>C4165060 | | LANDSLIDE FEATURE #6 AT ZONE 4 | Exhibit |

Close-up of hachured scene from exhibit A-12. From the former road alignment shown as the dashed yellow line, note how the landsliding has progressed up the slope to the point that the up-slope landsliding has almost (or in some cases, has) encroached into the current Big Flat Road prism. Once the landsliding from below has progressed up the slope, the landslide from below has removed part of the support for the current roadway, and landslides such as those seen on the previous Exhibits A-3 through A-11 (and many of the following Exhibits) will result.

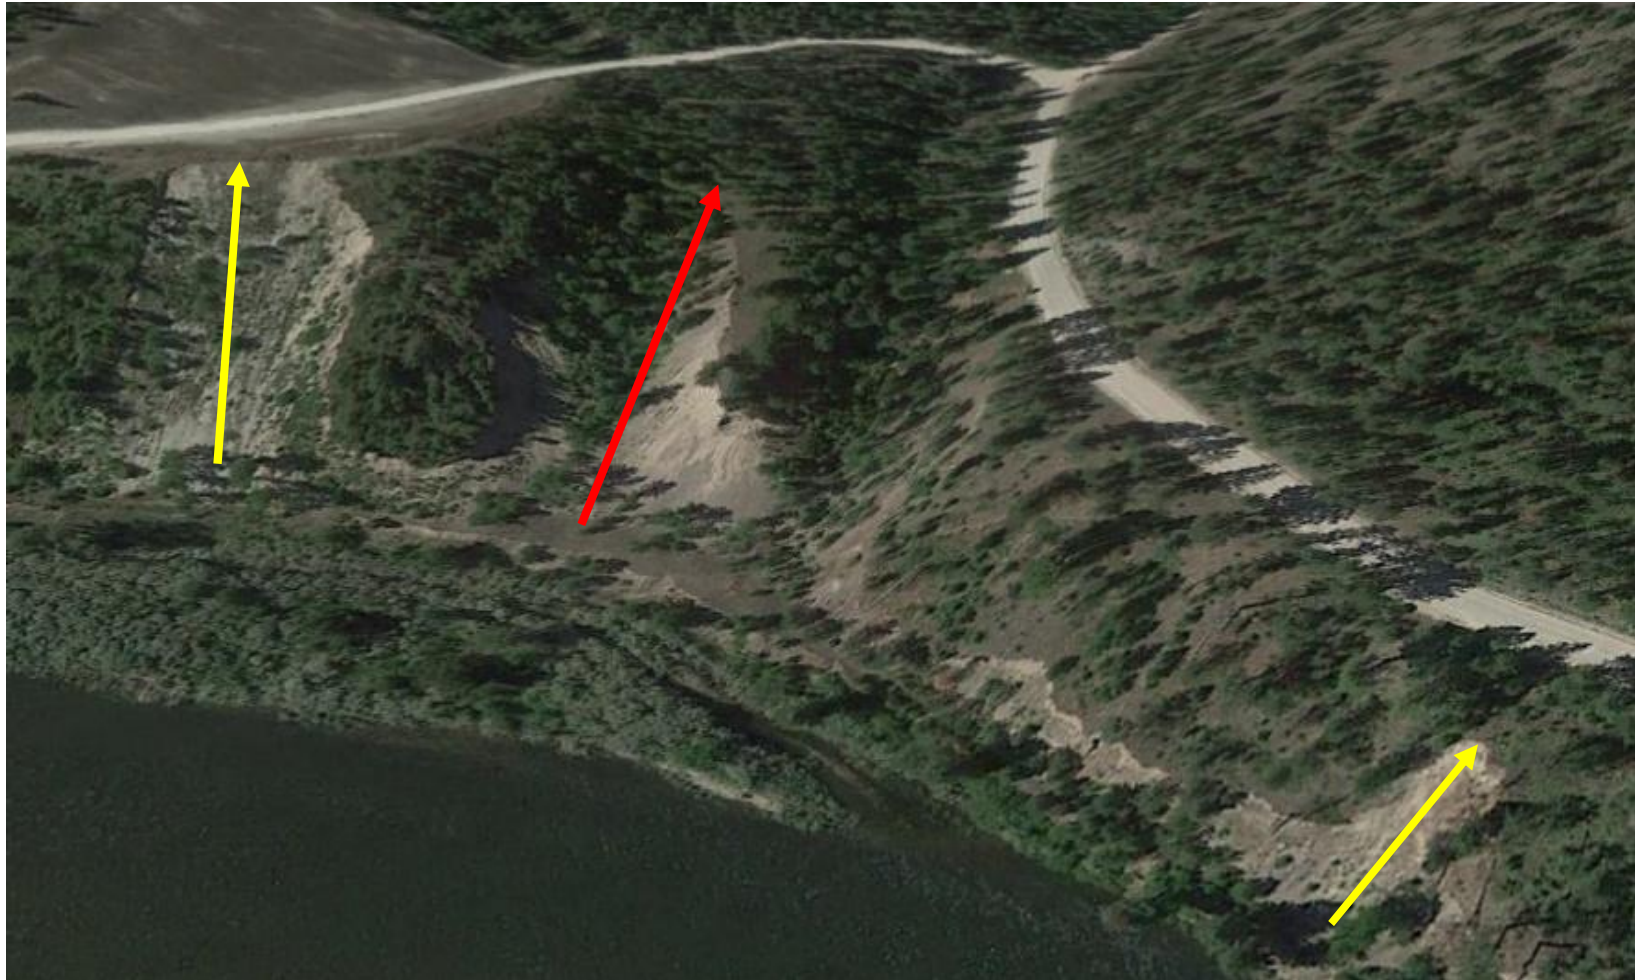
| Project Manager:<br>BJW | Project No.<br>C4165060 | <br><br>1392 13 <sup>th</sup> Ave SW      Great Falls, Montana 59404<br>PH. (406) 453-5400      FAX. (406) 761-6655 | LANDSLIDE FEATURE #7 ALONG ZONE 4 | Exhibit |

Another view of the Zone 4 Landslides further northwest from the Zone 3/Zone 4 interface. This scene shows 2 landslide areas (denoted by the yellow arrows) where sliding was initiated at the road cut along the old road alignment below and then progressed uphill toward Big Flat Road. The depression at the middle of the scene (denoted by the red arrow) is primarily erosional from the Dry Gulch drainage uphill to the southwest.
