# Geotechnical Engineering Report

**Big Flat Road Review**  
**Missoula County, Montana**  
May 17, 2017  
Terracon Project No. C4165060

Re: Geotechnical Engineering Report  
Big Flat Road Review  
Missoula County, Montana  
Terracon Project No. C4165060

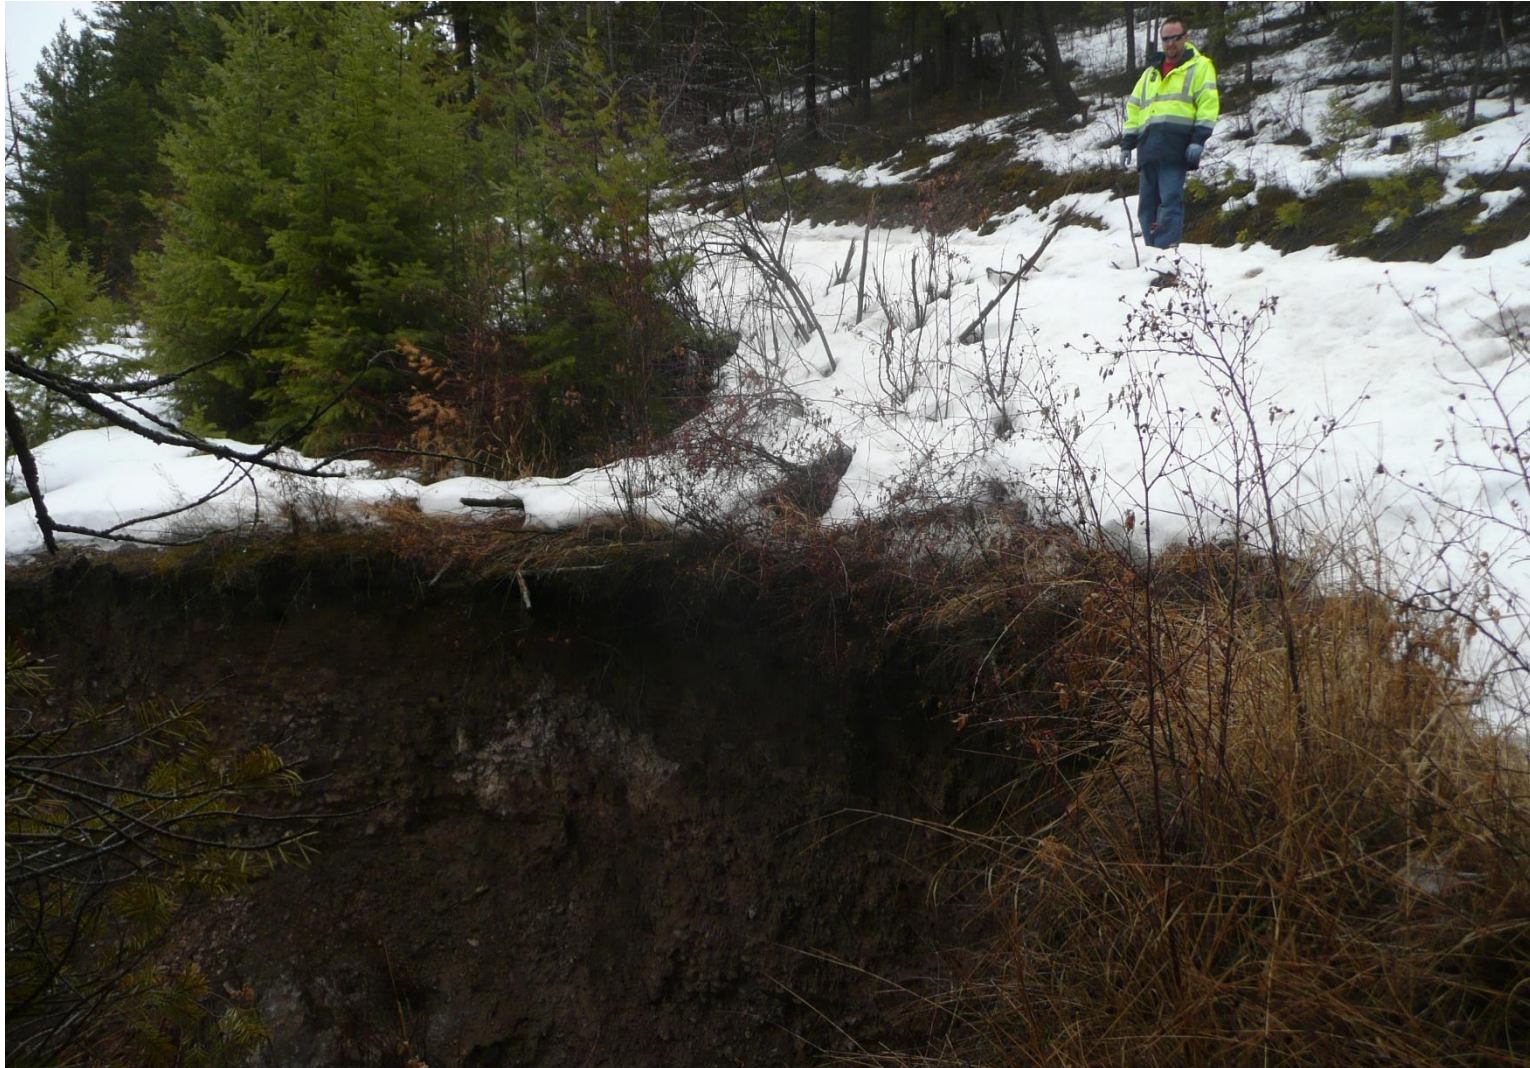
| Project Manager:<br>BJW | Project No.<br>C4165060 | <br><br>1392 13 <sup>th</sup> Ave SW      Great Falls, Montana 59404<br>PH. (406) 453-5400      FAX. (406) 761-6655 | LANDSLIDE FEATURE AT ZONE 5 MARCH 2014 | Exhibit |

**Landslide at Zone 5, March 10, 2014. This slide is located at the outside edge of the road. Note the relatively young trees that are tilting downhill in the immediate background of this scene, indicative of slope creep beyond the landslide limits.**

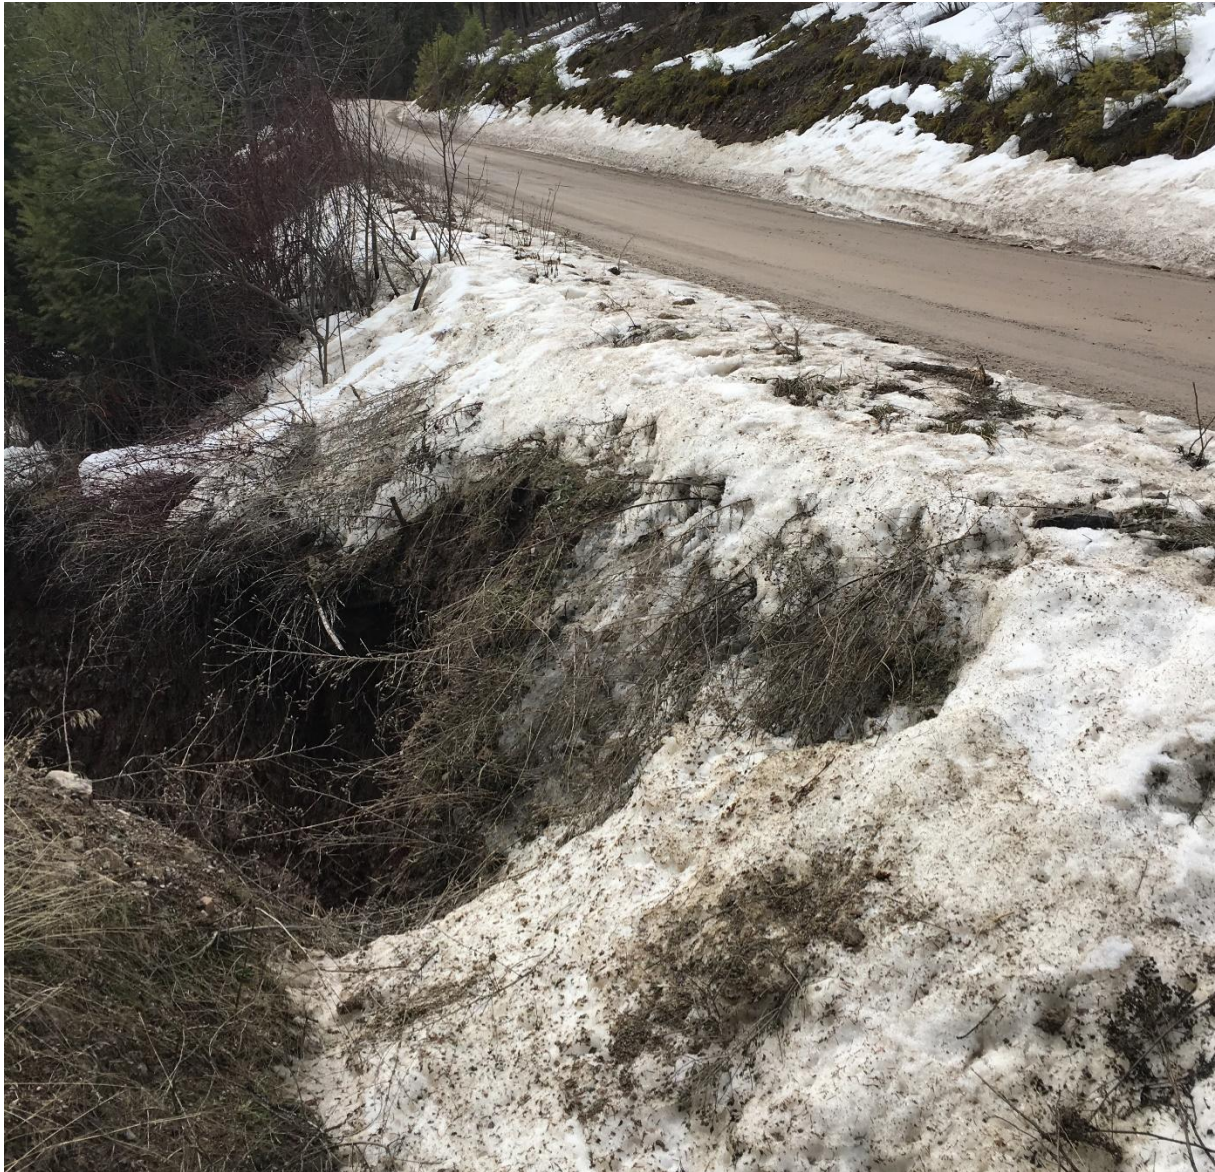
| Project Manager:<br>BJW | Project No.<br>C4165060 | | LANDSLIDE FEATURE AT ZONE 5 MARCH 2017 | Exhibit |

Landslide Zone #5 comprises a relatively limited failure zone, with measurements from early 2017 indicating a failure zone about 30 feet in length and 40 feet in height (see the attached Exhibits A-16 and A-17). One of the major issues with this landslide is that it is located within an area that exhibits slope instability, with some ground cracking and tilting vegetation (in response to downhill slope movement) evident on both ends of the current slide mass.

**Photo of Landslide Zone #5, March 15, 2017. The landslide has occupied essentially the same failure location as before.**

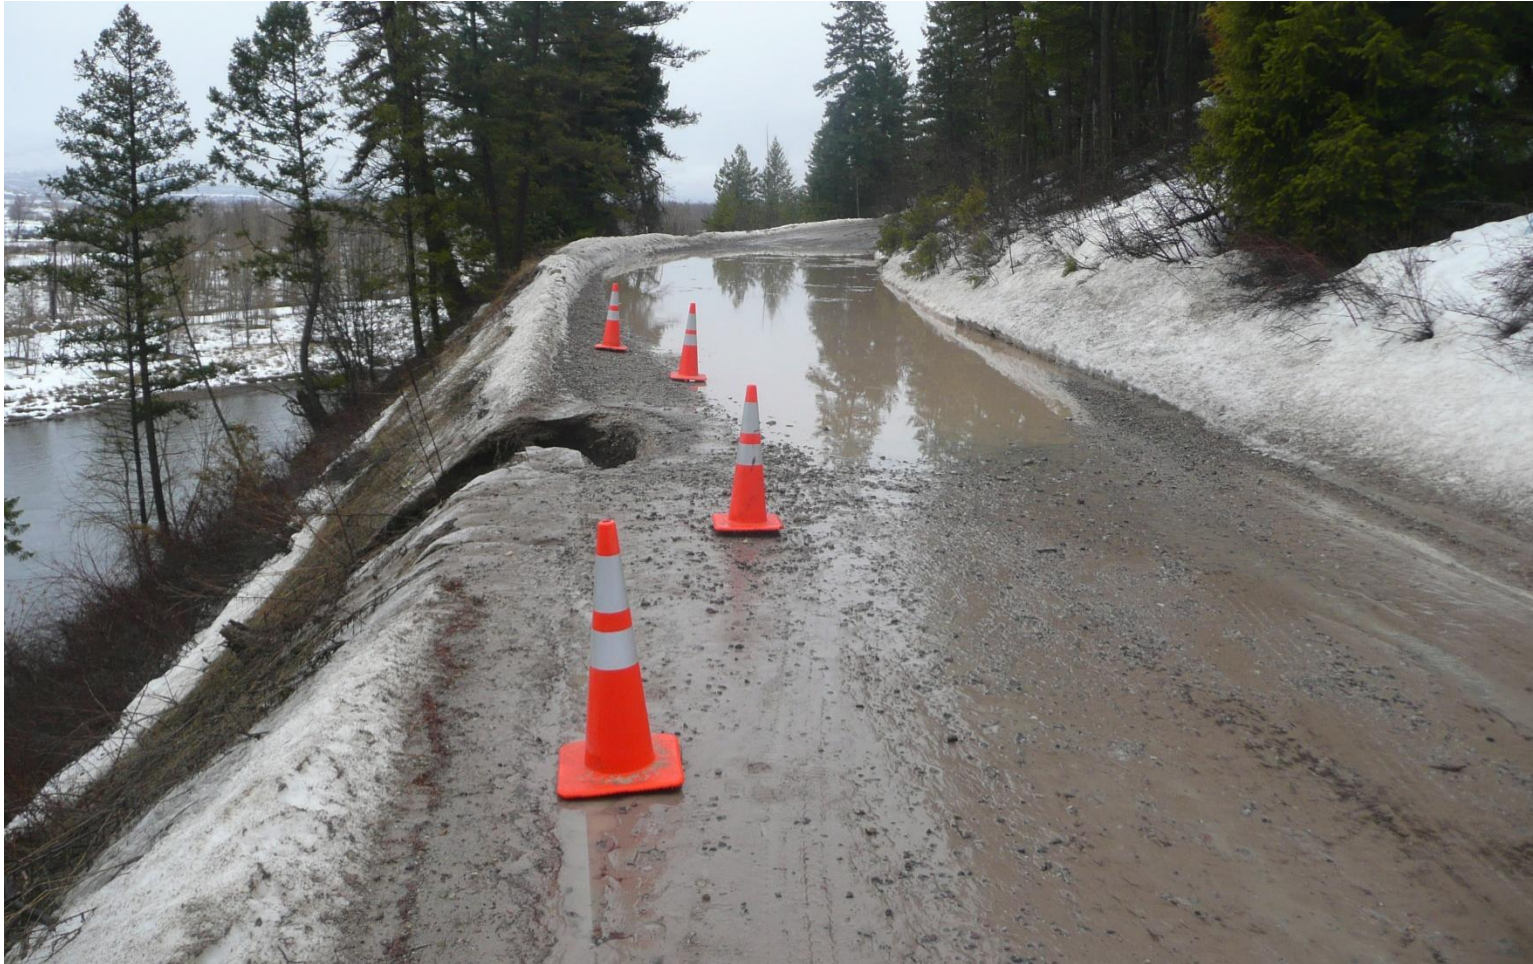
| Project Manager:<br>BJW | Project No.<br>C4165060 | <br>1392 13 <sup>th</sup> Ave SW    Great Falls, Montana 59404<br>PH. (406) 453-5400    FAX. (406) 761-6655 | LANDSLIDE FEATURE AT ZONE 6, MARCH 2014 | Exhibit |

This photo, taken March 10, 2014, shows both an erosional event (due to poor roadway drainage) as well as small-scale landsliding at Landslide Zone #6. Note the tilted trees in the background that are exhibiting various degrees of slope creep.

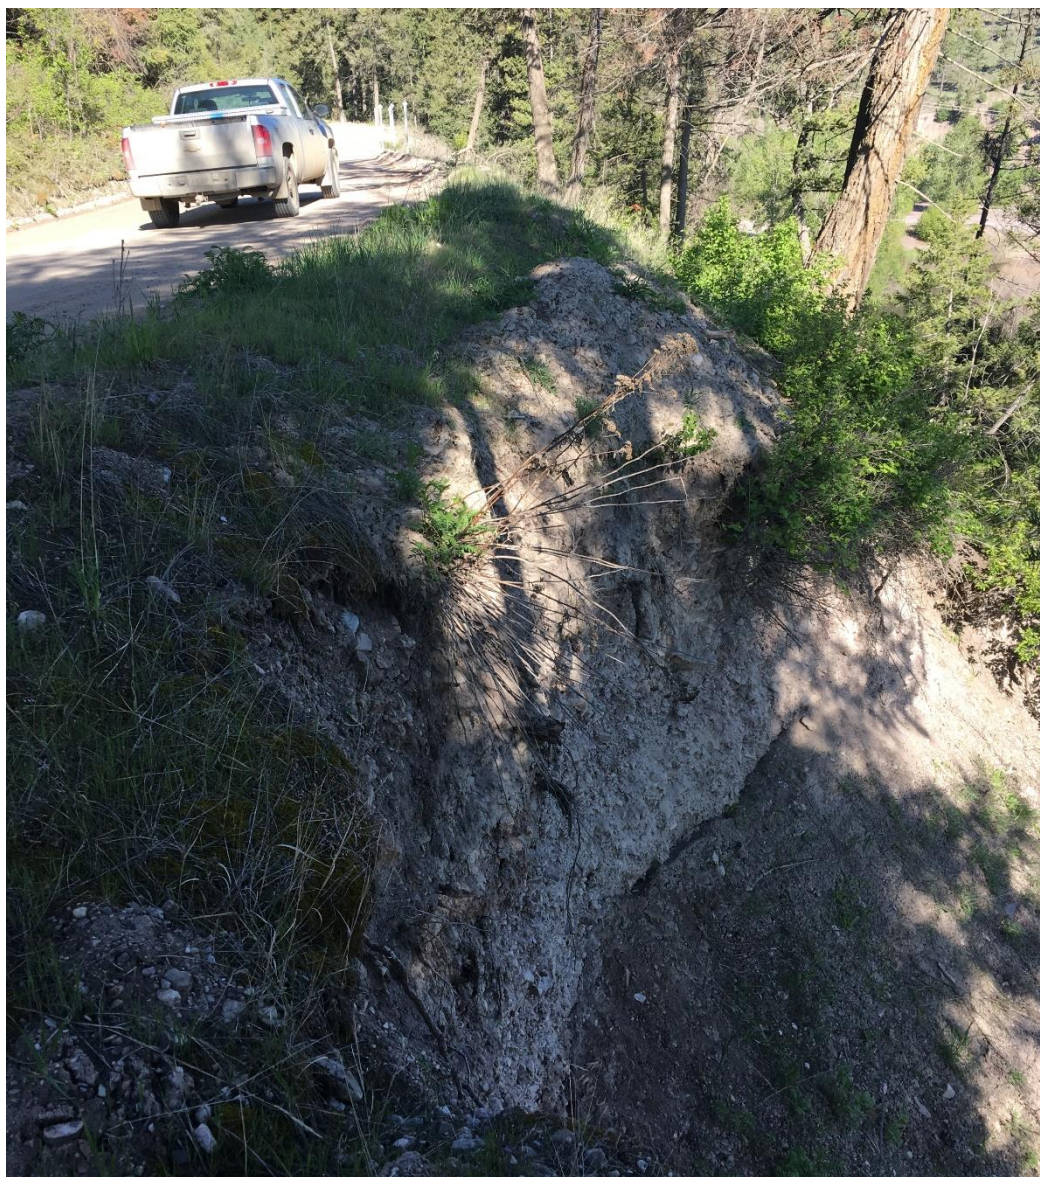
**Photograph of renewed landsliding at Zone 6 in March of 2016. Note the over-steepened slope within the landslide as well as the large-diameter Trees tilting downhill just beyond the current landslide zone.**

**Repair and stabilization of slopes such as this is difficult due to the limited width of the road (within which to conduct excavation) as well as the steepness of the landslide scarp and slope below the outside edge of the road. From a practical standpoint, the entire width of the road would likely have to be employed (and the existing uphill cut slope extended further into the hillside) to accommodate excavation and construction to stabilize this slope.**

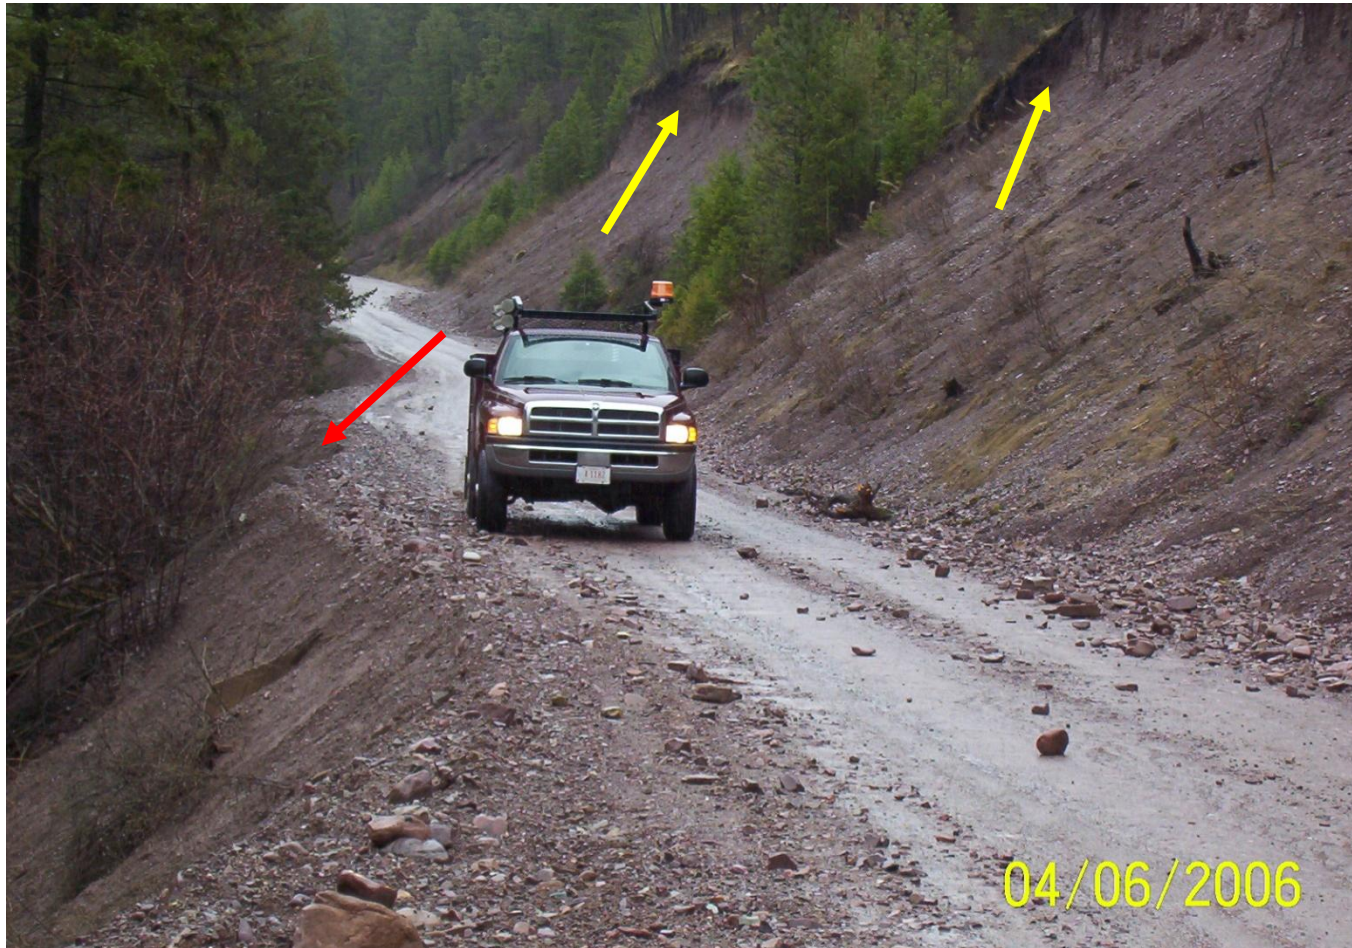
| Project Manager:<br>BJW | Project No.<br>C4165060 | <br>1392 13 <sup>th</sup> Ave SW    Great Falls, Montana 59404<br>PH. (406) 453-5400    FAX. (406) 761-6655 | LANDSLIDE FEATURE #1 AT ZONE 7, APRIL 2006 | Exhibit |

Photograph of landsliding and slope erosion along Landslide Zone #7. The yellow arrows above the road indicate uphill-propagating landsliding, the same as the large-scale landsliding observed in Landslide Zone #4 below the current Big Flat Road. The red arrow indicates the small-scale landsliding that is observed along much of this reach of Big Flat Road.

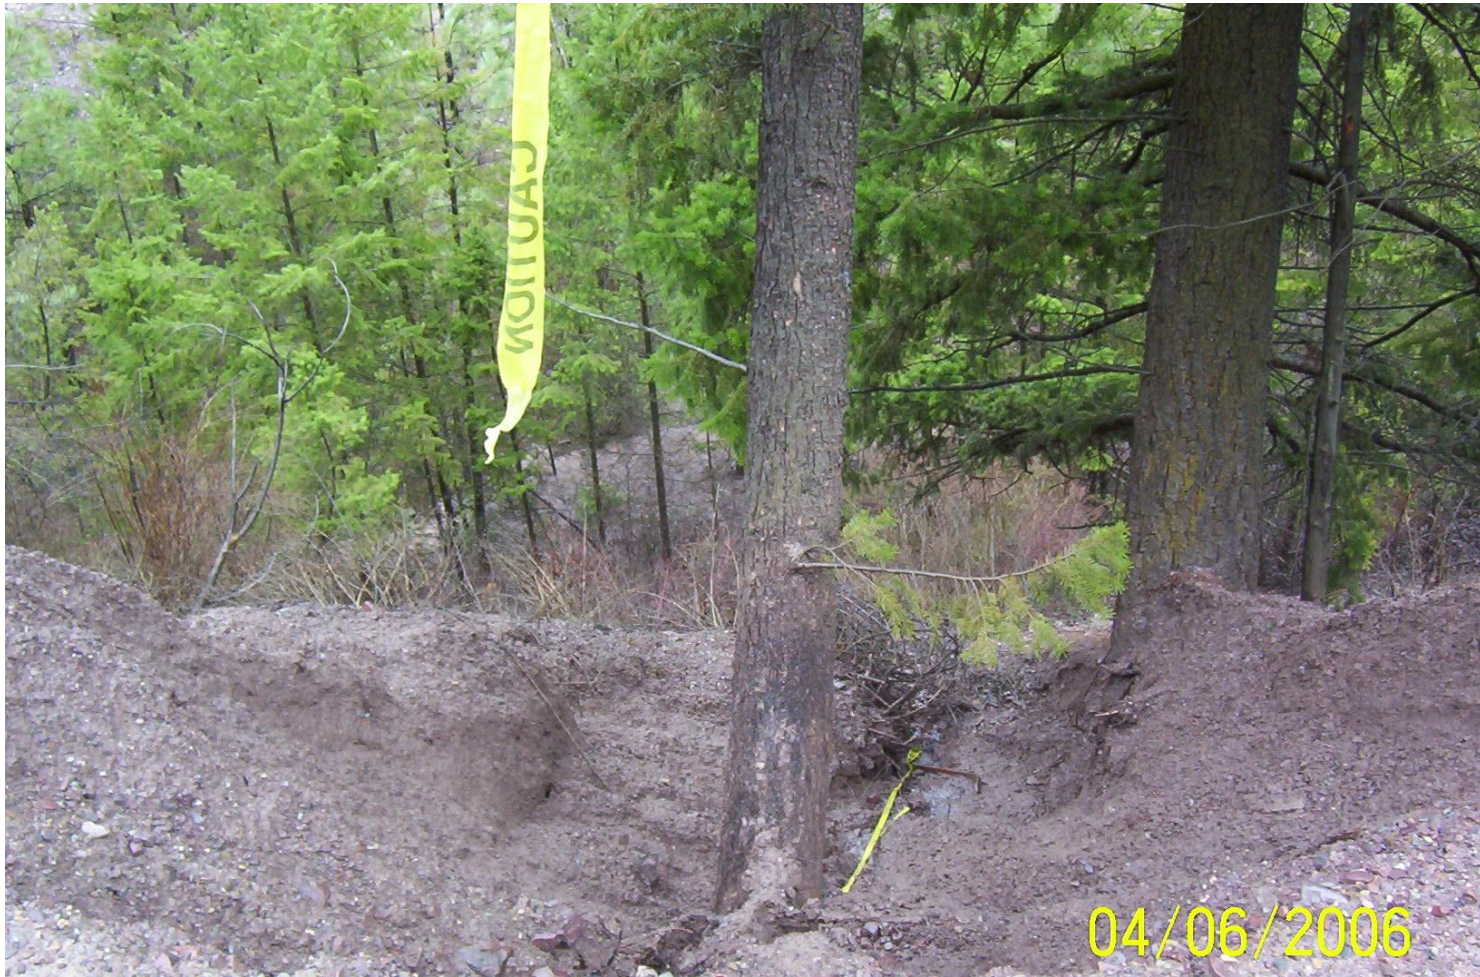
| Project Manager:<br>BJW | Project No.<br>C4165060 | | LANDSLIDE FEATURE #2 AT ZONE 7 APRIL 2006 | Exhibit |

View downhill at small-scale landslide/slope erosion feature along Landslide Zone #7. This photo shows erosion and sliding of fill and (uphill) slide debris that has been cast downhill of the roadway, partially burying trees in locations such as this. The downhill slope surface in this area is only sparsely vegetated, allowing for erosion and small-scale sliding of the slope during spring runoff.

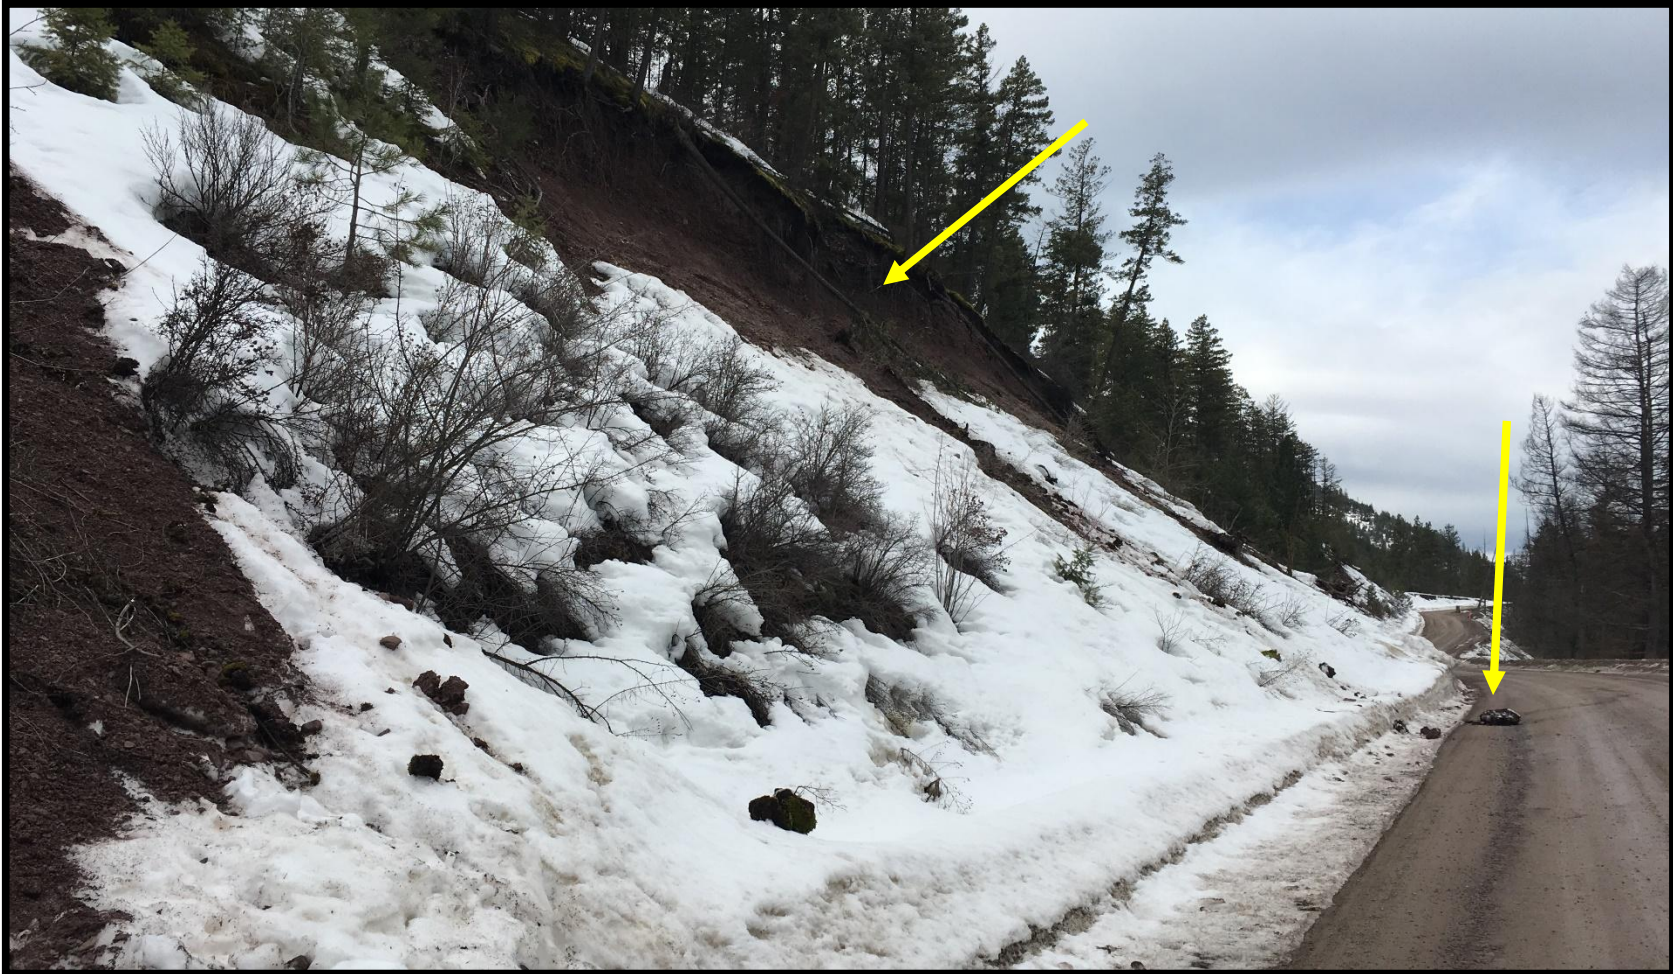
| Project Manager:<br>BJW | Project No.<br>C4165060 | | LANDSLIDE FEATURE AT ZONE 7 MARCH 2017 | Exhibit |

Photograph of headward slope erosion and erosional debris on Big Flat Road, Landslide Zone 7 (see yellow arrows). At this location, slope erosion progresses uphill until a sufficient overhang develops, at which time either the overhang falls off or a block of the uphill slope fails and slides downhill. Currently, such erosion primarily generally poses only a maintenance issue, but eventually, larger-scale erosion and landsliding of this slope will pose a danger to the roadway.
