Missoula County Bridge Rehabilitations Preliminary Engineering Report

- *Schwartz Creek Road Clark Fork River Bridge*

Prepared For: Missoula County Public Works

Reviewed by: Charlie Brisko, PE
Date: 03/19/2025

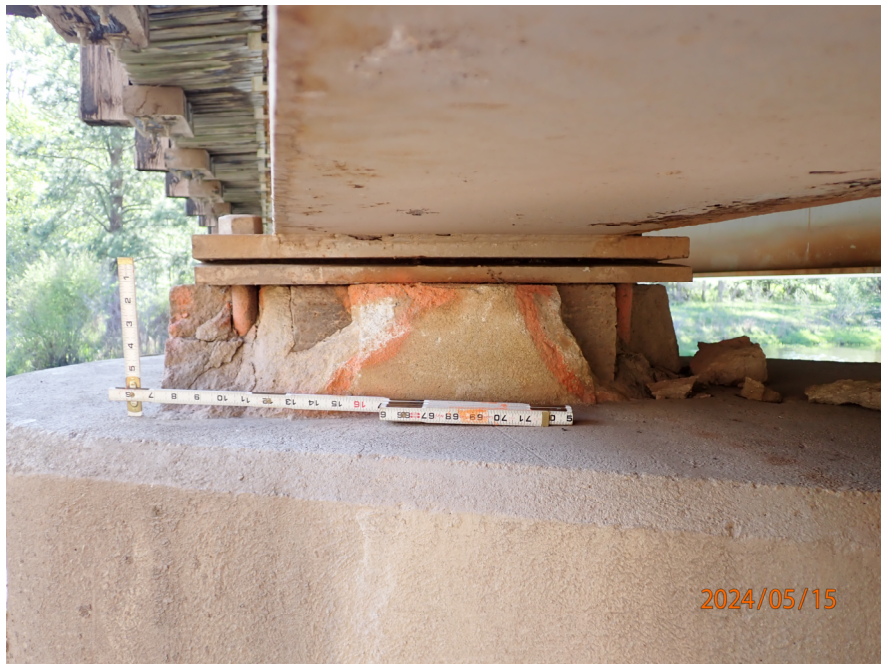
FIGURE 4: BENT NUMBER 3 PEDESTAL

- Cracked and spalled concrete bearing pedestals at Bent Number 3.
- Spalls in concrete pier caps at Bent Number 2 and Number 4.
- Crack/delamination/spall at Abutment Number 1.
- Undermining of earthwork at Abutment Number 1.
- Cracks in tack welds at two intermediate diaphragms in spans 2 and 3.
- Bent anchor rod at Bent 2.

Further review of the pedestal spalls revealed that there is an existing steel block within the concrete pedestal that supports the steel girder bearings. Therefore, the repair would not require any jacking of the superstructure. The suggested repair is to remove any loose concrete within the pedestal, preferably all pedestal concrete, and replace with a high strength grout pedestal of the same size. The grout would have much higher compressive strength than the existing concrete and would also have much better bond capabilities to the existing steel and concrete. Additionally, reinforcing steel dowels could be installed vertically into the bent cap to allow for additional rebar placement.

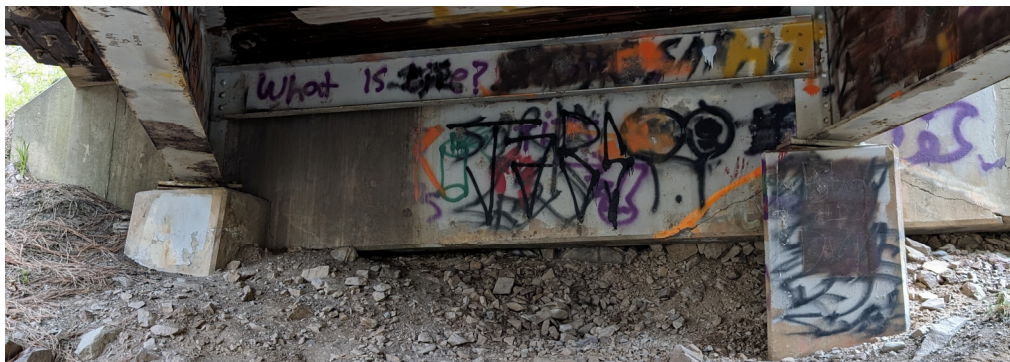
FIGURE 6: ABUTMENT NUMBER 1

The crack at abutment 1 may have been caused by the undermining of the earthwork under the bent or by settlement of the abutment segments. Since the crack may have a structural cause, it should be monitored for any further separation. The recommended repair at the existing crack at abutment 1 is to remove any delaminated concrete, clean cracks, fill with low viscosity injection epoxy, and repair area as described above for spalled concrete. Removal of delaminated concrete may not be necessary as a structural crack would not have much delamination. Consequently, care should be taken when removing loose concrete. Additionally, earthwork and riprap should be added at abutment 1 underneath and in front of the backwall.
