Preliminary Engineering Report

BENCH ROAD OVER GRANT CREEK

Structure ID: 03761

Missoula County, Montana

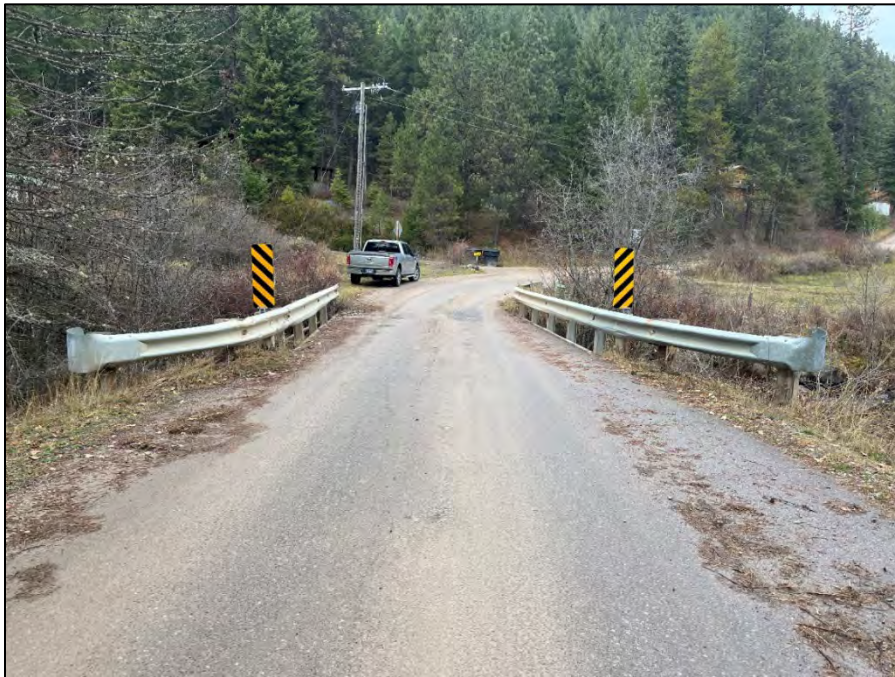
Figure 2: View of the existing bridge approach looking from the south to north

The existing bridge is located between two horizontal curves on a tangent section of roadway. The approach from the main Grant Creek Road is located approximately 400 feet to the south.

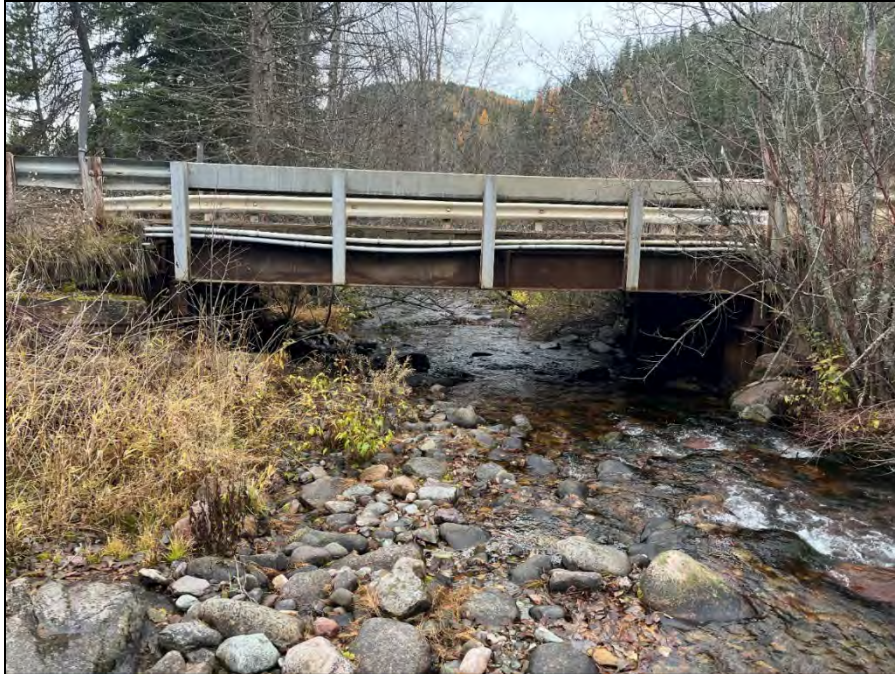
Figure 3: View of the existing bridge looking downstream.

The bridge superstructure consists of five steel girder members with steel diaphragm angles. The steel girders have splices with rough cuts and welds. The substructure consists of steel columns and a steel cap member. The steel members appear to be salvaged from another project and are likely older than the 1955 construction date.

- Minimal paint remaining (paint failure) on steel girders and steel abutment members with surface corrosion.
- Splices on steel girders have rough cuts and welds with no paint remaining.
- Pack rust and swelling on steel abutment members. Members are salvaged from other bridges.
- Steel pier caps have corrosion with excess rotation.
- Asphalt on the bridge deck is rough with potholes.
- Impact damage on approach guardrail.

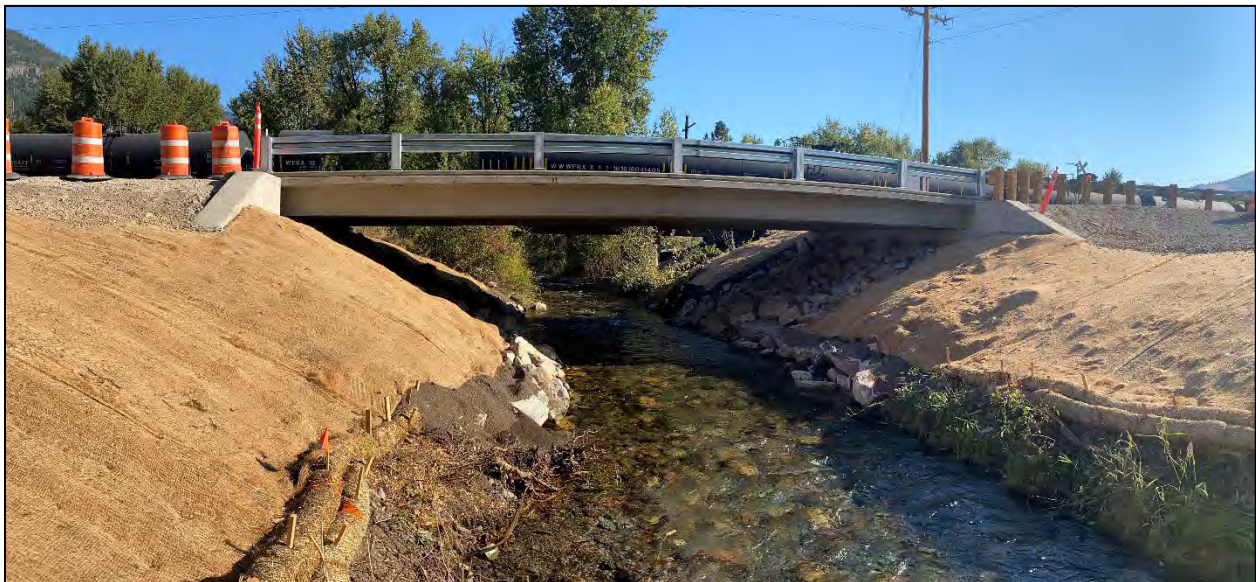
Figure 4: Example prestressed concrete girder system

This superstructure system simply involves setting the girders in place, welding them together, and grouting the seams between adjacent members. The final step involves casting concrete end diaphragms. The use of a prestressed, precast concrete deck system allows for a quick and efficient installation of the superstructure. The quality control of this alternative can also be closely monitored as the beams are cast and cured in a controlled environment.

Construction of the trideck superstructure, including placement and installation, can be completed in 1-2 weeks. This alternative is essentially maintenance free and has a projected service life of 75 years.

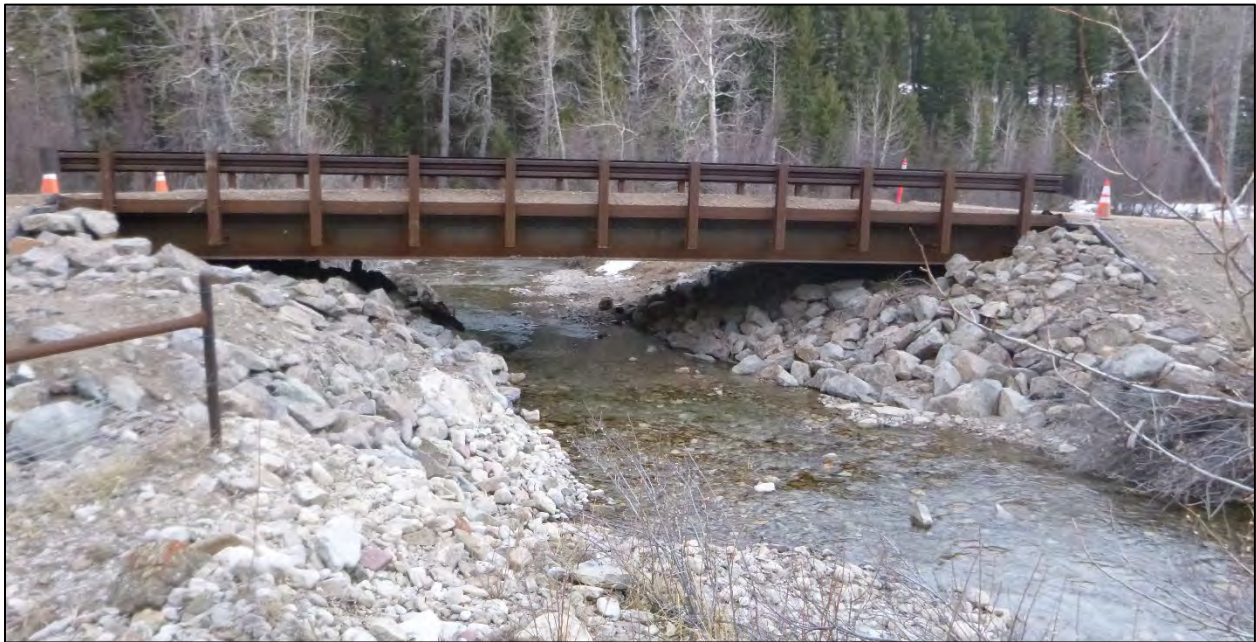
Figure 5: Example prefabricated steel girder system

This single span alternative would utilize a prefabricated steel girder system with a corrugated steel deck. A preliminary design indicates that two to three modular bridge sections would be necessary to ensure a usable bridge width of 18 feet. The decking system will consist of galvanized steel corrugated bridge panels which are welded to each steel girder. The steel decking would be filled with concrete or asphalt to match the adjacent approaches. Riprap placement at a 2:1 slope underneath the bridge requires the steel girders to span 55-feet.

This alternative would require a relatively minor amount of maintenance. The steel girders would be constructed with A588 weathering steel which will not require painting. Construction of the steel modular bridge system including placement and installation can be completed in 1-2 weeks. The projected service life for this alternative is 75 years, if maintained properly.

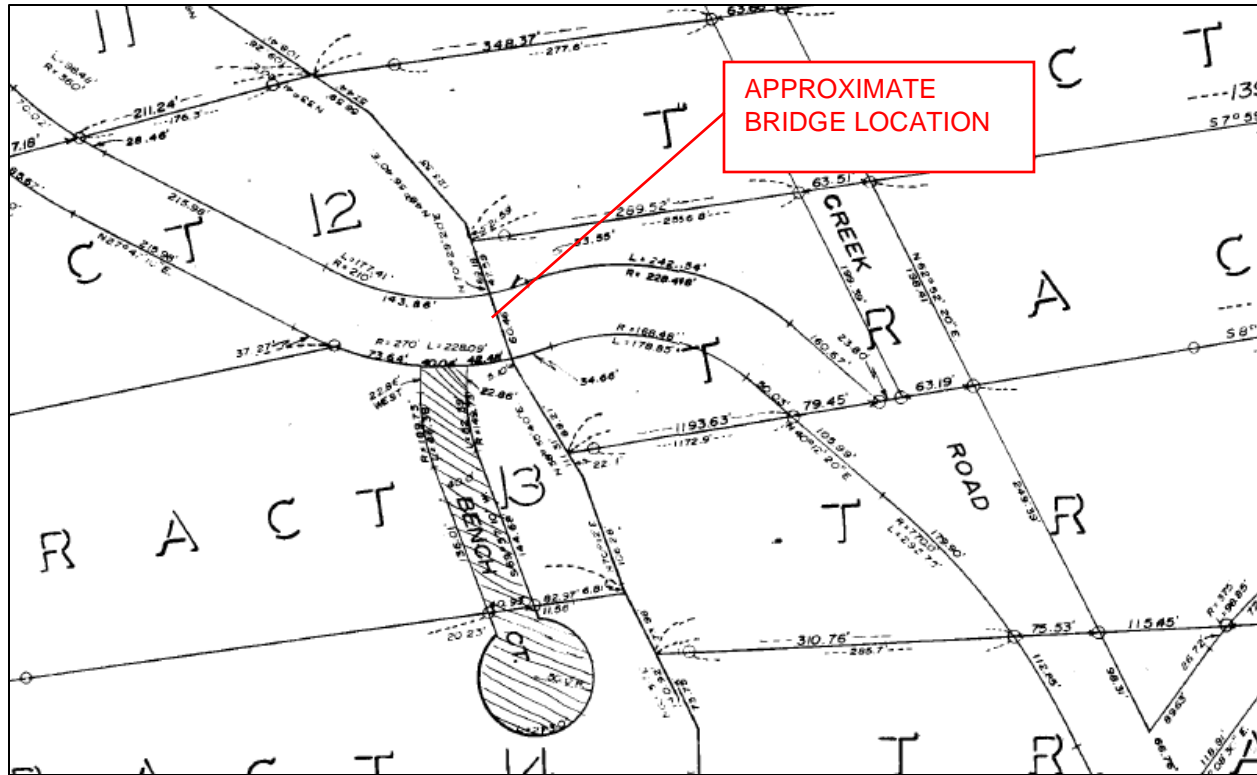
Figure 6: Right-of-way map in bridge vicinity

Regardless of the selected alternative, the replacement structure will be constructed in essentially the same location as the existing bridge. Since a feasible detour route is not available, a bypass bridge and road will be installed adjacent to the existing structure to provide access to residences throughout construction operations. If temporary easements or construction agreements are required to construct the improvements, the County will work with the adjacent landowners to procure access during the design phase. The County has contacted adjacent landowners and they have stated they are in support of the project.

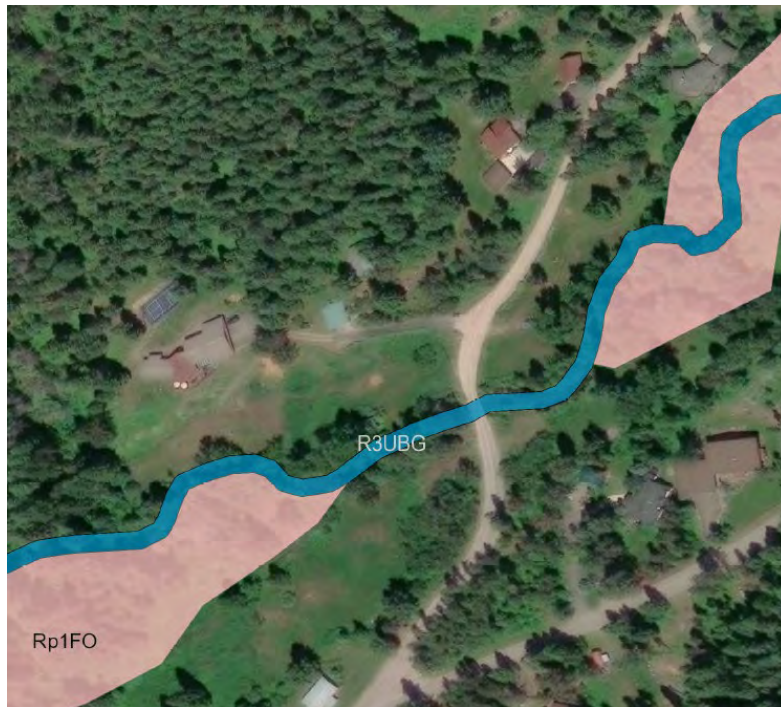
Figure 7: National Wetland Inventory mapping in bridge vicinity

Upon review of the USFWS National Wetland Inventory Mapping (Attachment B), no wetland habitat occurs within the project area. A wetland delineation may still be necessary to verify the presence/absence of wetland habitat, as well as defining the Ordinary High-Water Mark (OHWM).

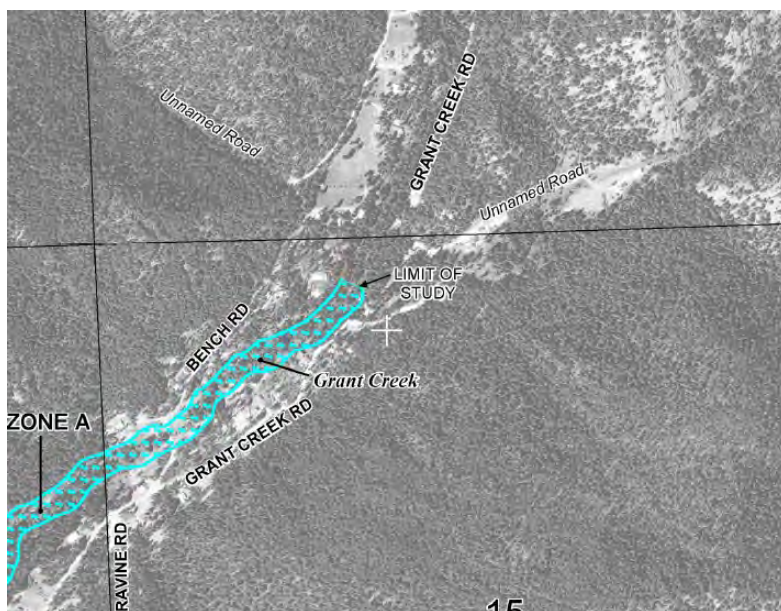
Figure 8: Floodplain map in bridge vicinity

The project area lies within Flood Zone A according to the FEMA-Flood Insurance Rate Map (Attachment C), and a County Floodplain Permit will likely be required.

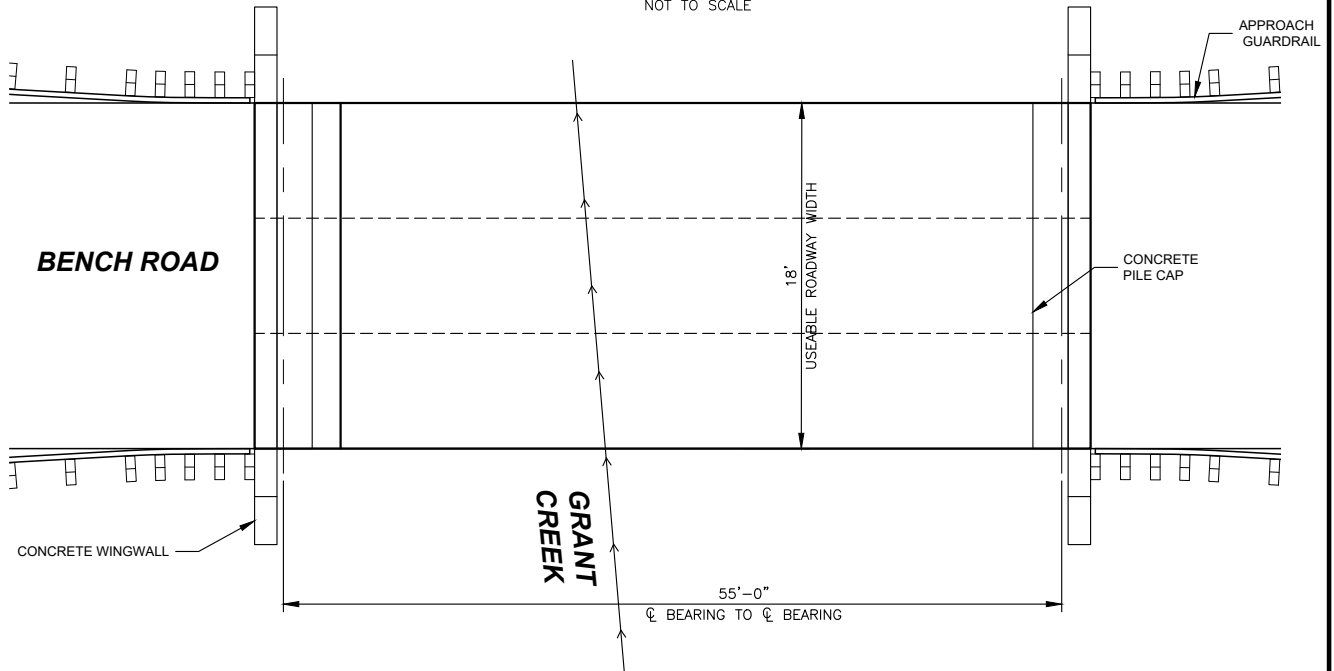
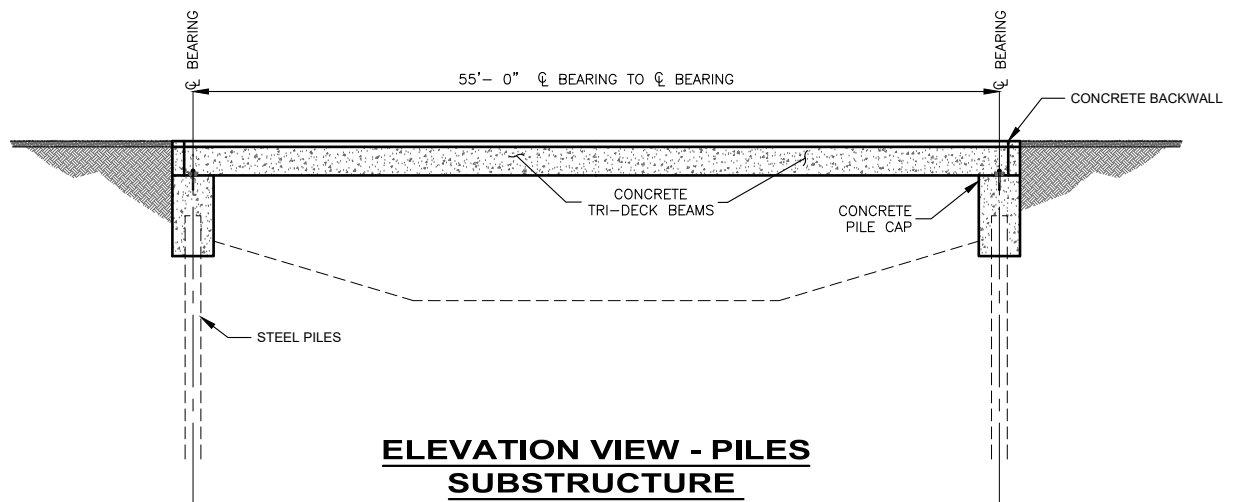
BENCH ROAD BRIDGE REPLACEMENT FIGURE 5 - PRESTRESSED CONCRETE GIRDERS

PLAN VIEW - CONCRETE TRI-DECK BEAM BRIDGE SUPERSTRUCTURE ALTERNATIVE 1

ELEVATION VIEW - PILES SUBSTRUCTURE

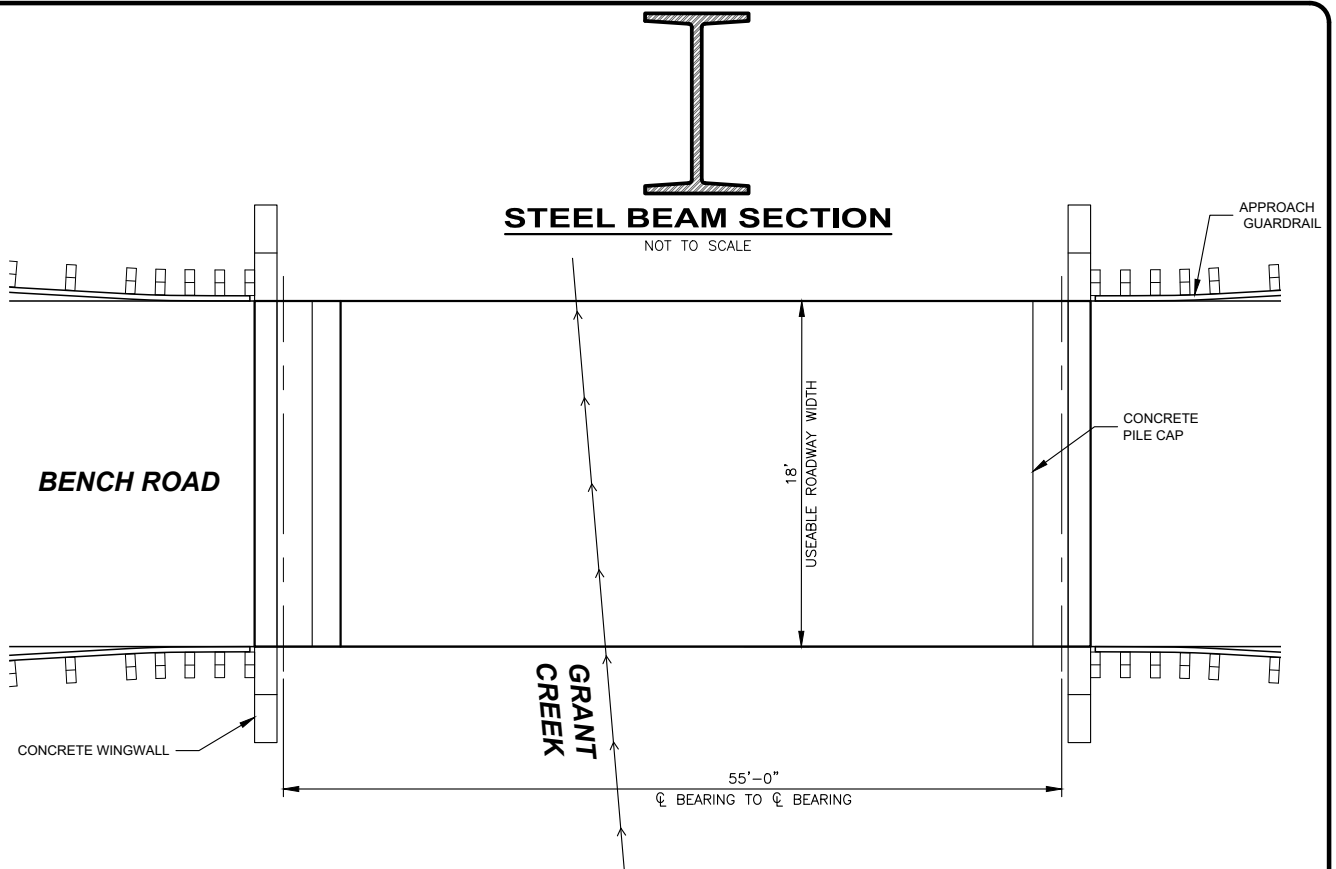
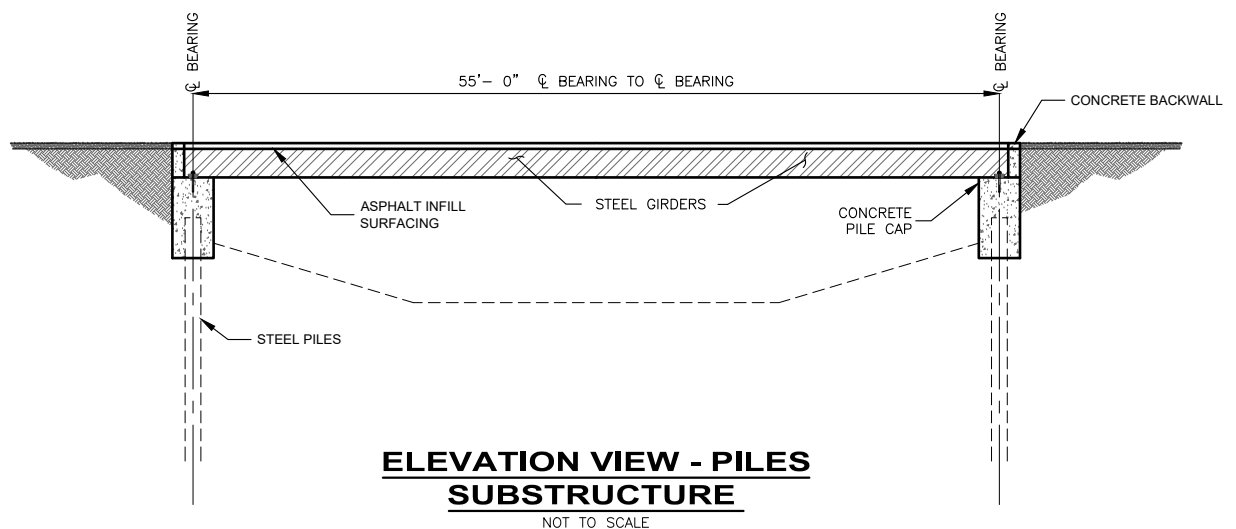
BENCH ROAD BRIDGE REPLACEMENT
FIGURE 6 - PREFABRICATED
STEEL GIRDERS

PLAN VIEW - PREFABRICATED STEEL GIRDERS
SUPERSTRUCTURE ALTERNATIVE 2
NOT TO SCALE

ELEVATION VIEW - PILES
SUBSTRUCTURE
NOT TO SCALE

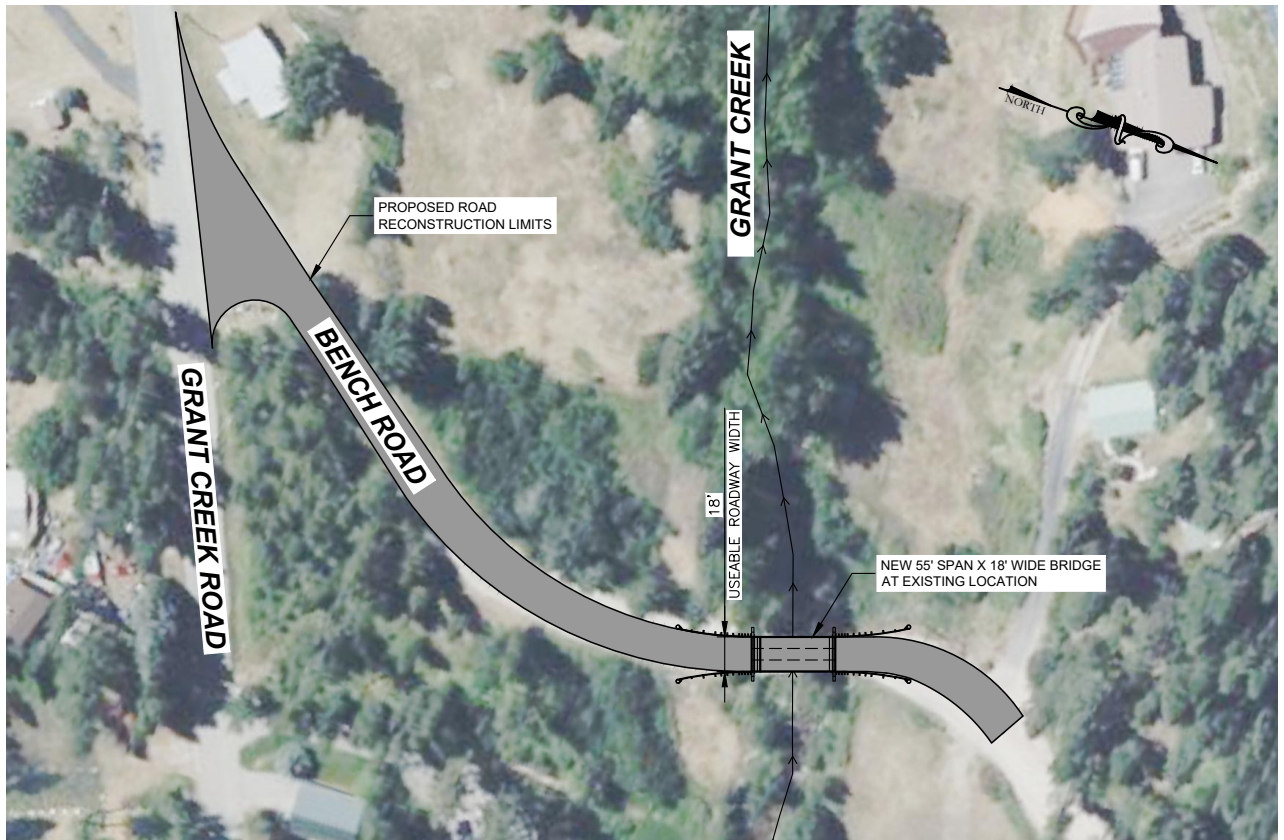
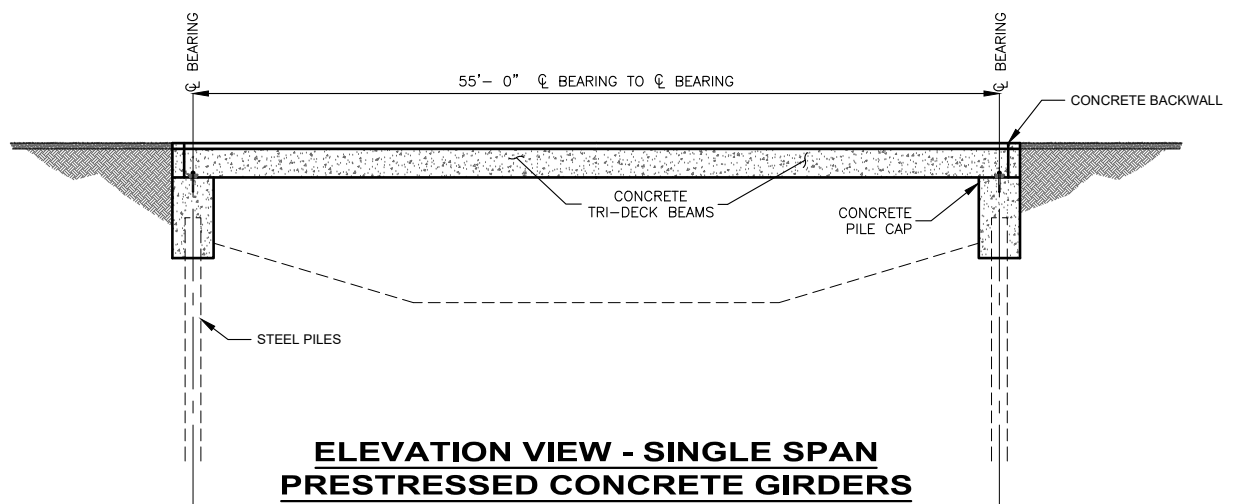
BENCH ROAD BRIDGE REPLACEMENT FIGURE 7 - PREFERRED ALTERNATIVE

PLAN VIEW - SINGLE SPAN PRESTRESSED CONCRETE GIRDERS

ELEVATION VIEW - SINGLE SPAN PRESTRESSED CONCRETE GIRDERS

Thus, largely based on long term viability and capital cost, the preferred alternative for the replacement of the Bench Road Bridge utilizes precast, prestressed concrete trideck girders with a driven pile foundation. The estimated total cost for the preferred alternative with roadway costs is approximately \$950,000. The entire project will be contracted out to an experienced bridge contractor. Refer to the following table for a summarization of the selection process.

BRIDGE PARAMETER	PROPOSED STRUCTURE
Total Span Length (out to out)	55'
Skew	0 degrees
Usable Width (between rails or curbs)	18'-0"
Overall Deck Width	20'-4"
Superstructure Type	Prestressed Concrete Trideck Girders (Integral Deck)
Substructure/Foundation Type	Driven Piles with a Concrete Cap
Structure Depth	30"
Proposed Deck Elevation	3957.89'

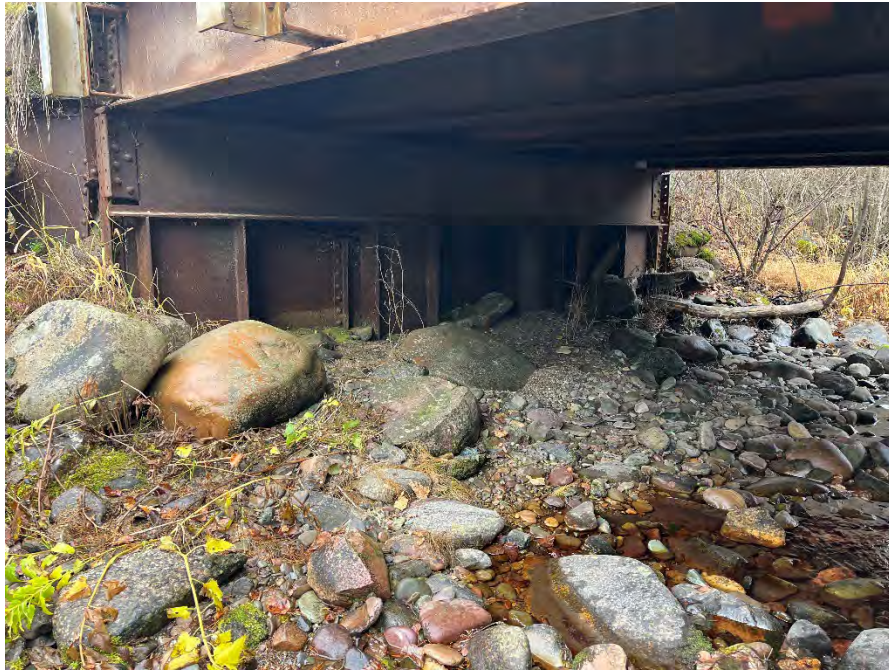
Photo #7 – View of Abutment 1

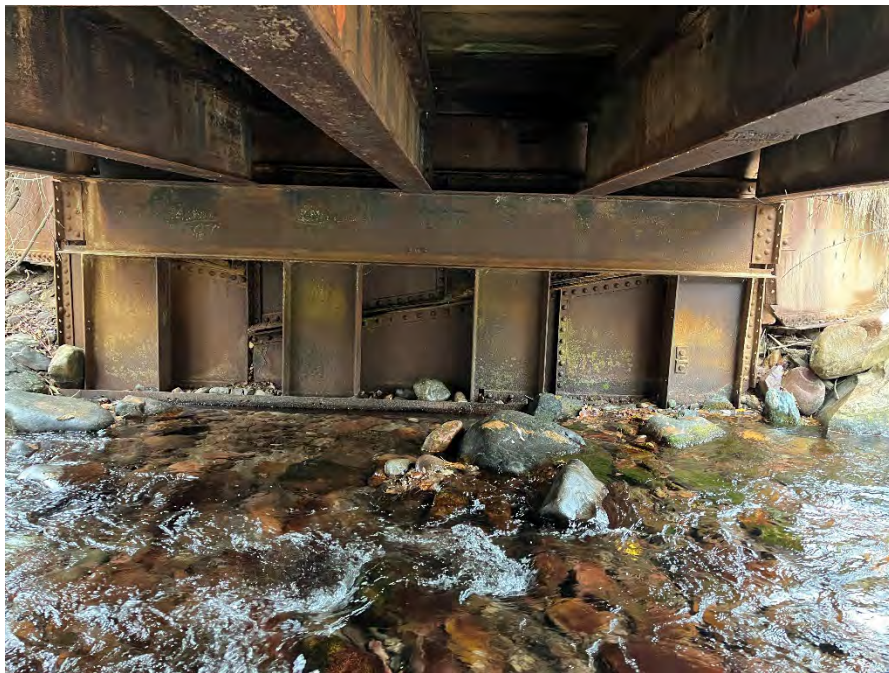
Photo #8: View of Abutment 2

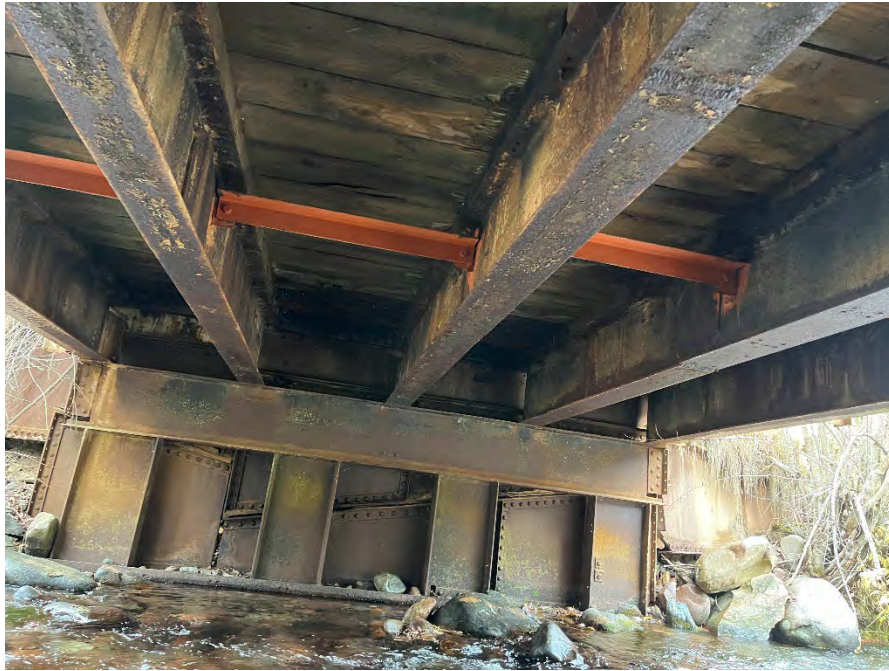
Photo #9 – Underside of deck (typical).

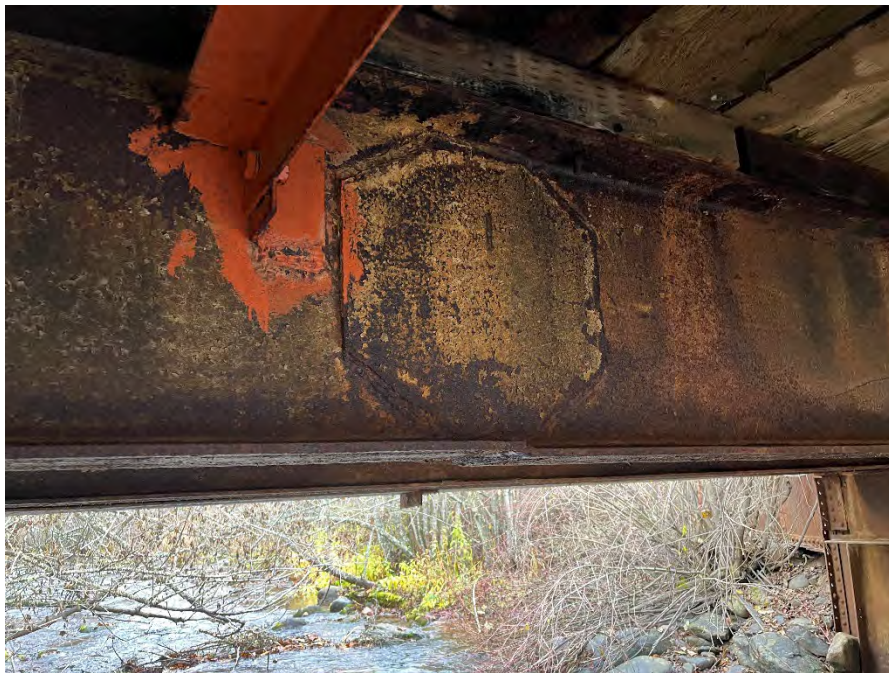
Photo #10: View of poor quality spliced girder members

Note:Girders have welded splices at approximately 1/3 point of each girder, no signs of distress were noted in the welded splice.

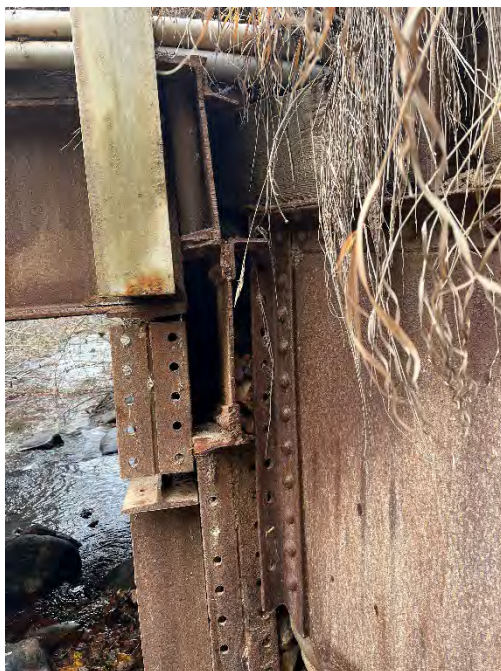
Photo #11 – View of Abutment 2 with member separation and rotation.

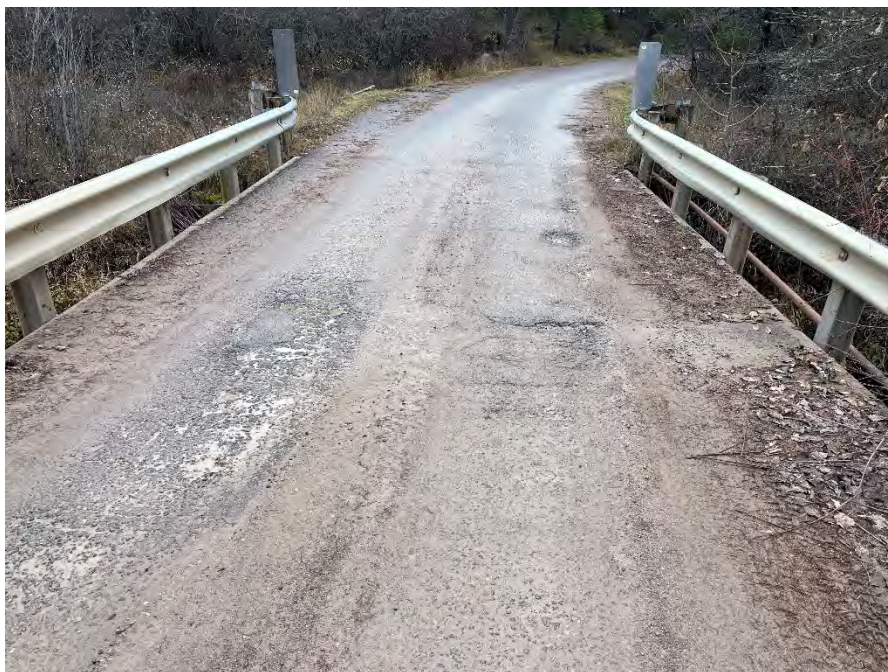
Photo #12: View of deck condition with previous asphalt loss.

The wearing surface has (2) potholes up to 6' x 3' beginning to form in the right wheel path.

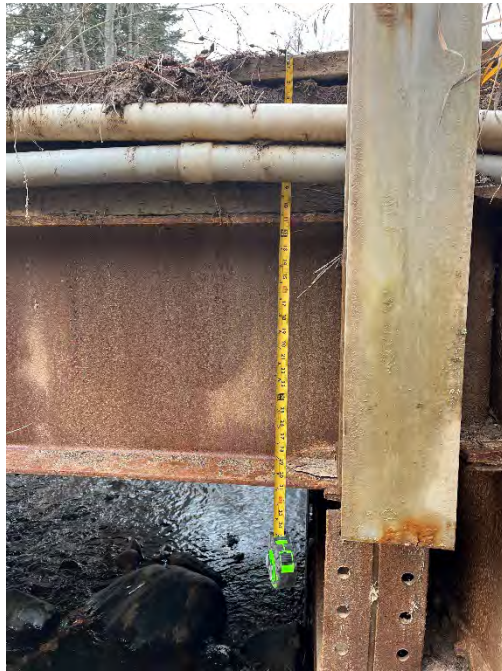
Photo #13 – View of upstream utility conduits

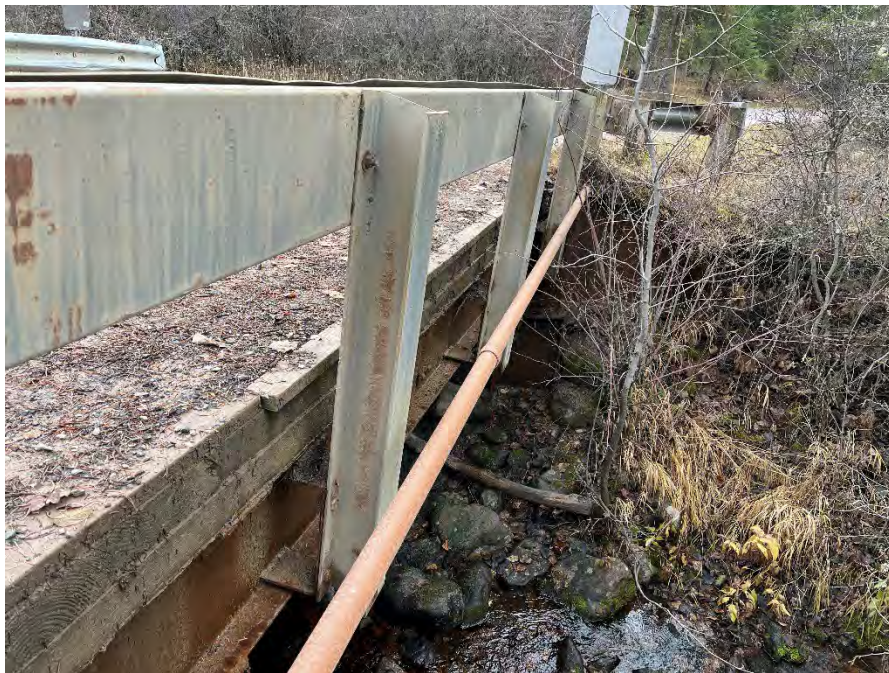
Photo #14: View of downstream utility conduit

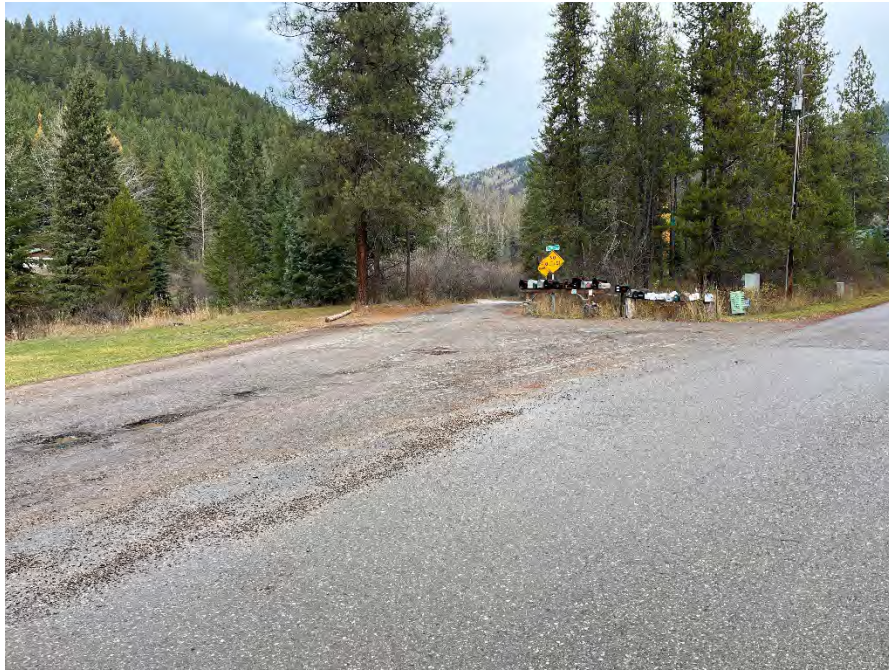
Photo #15 – View of poor quality asphalt condition at Grant Creek Road

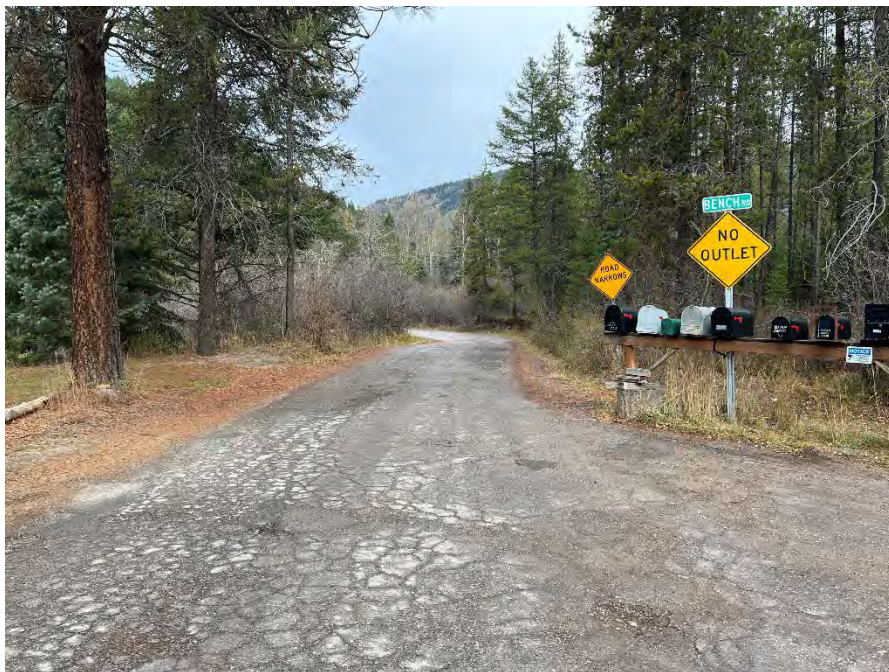
Photo #16: View of asphalt cracking and failure near Grant Creek intersection

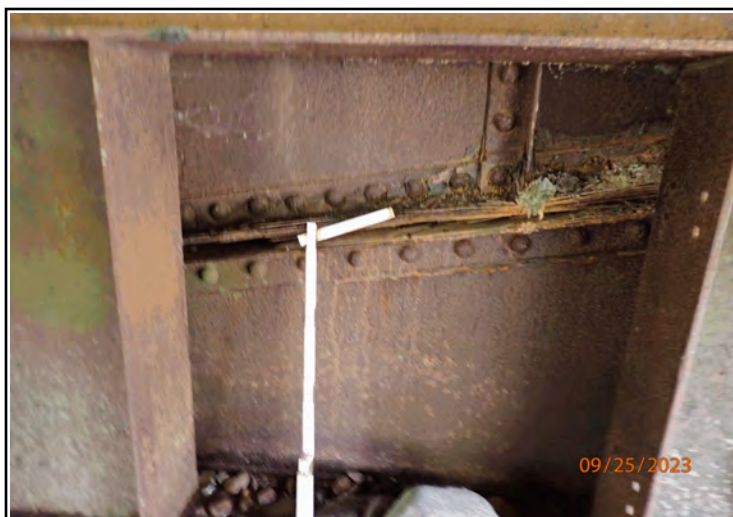
Steel abutment at bent 1 and 2 have areas of pack rust swelling between built up areas. all sections of structure are from different bridges.

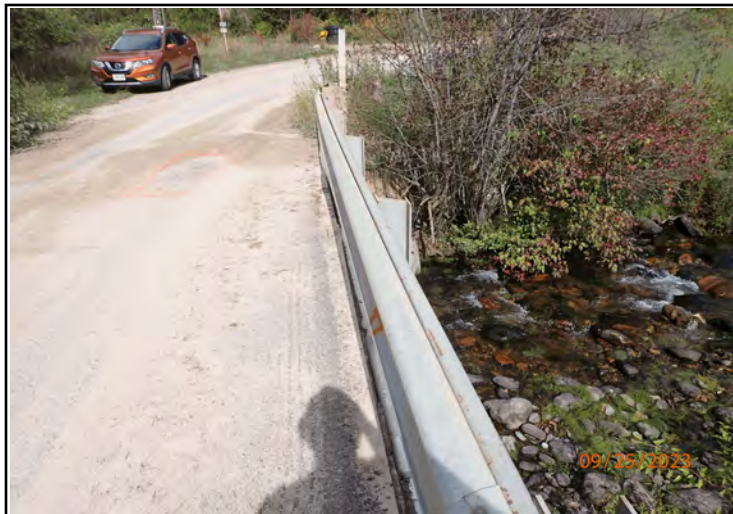
Flattened and rusty rail full length left and right, cs2 full length.

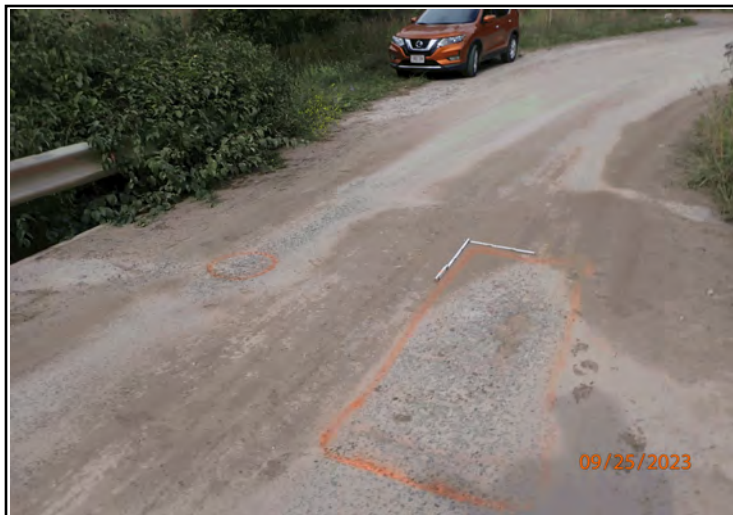
Areas of patching of 2-inch-deep plant mis surfacing. Near bent 2 end.

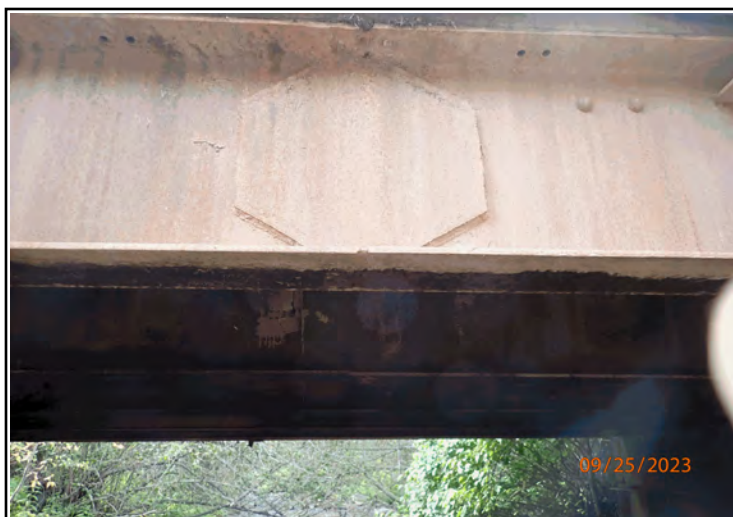
Typical of steel girder splices girder 5 shown.

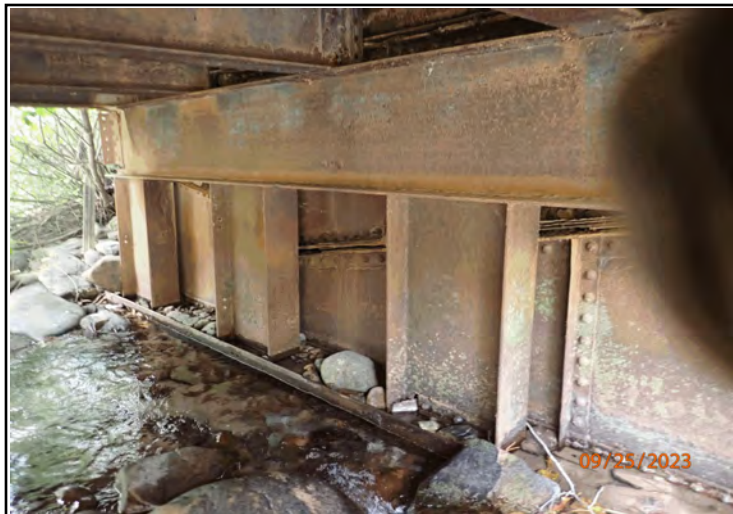
Abutment, column and sill make up all steel no paint remaining.
Some pack rust between built up areas in back walls.
