Missoula County Bridge Rehabilitations

Preliminary Engineering Report

- *Petty Creek Road Clark Fork River Bridge*

Prepared For: Missoula County Public Works

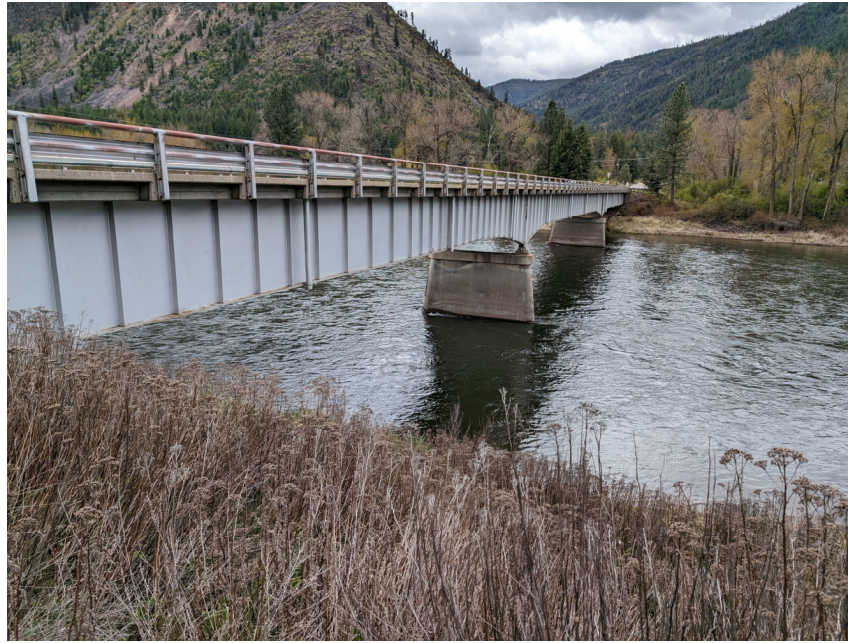
FIGURE 2: PETTY CREEK ROAD BRIDGE GENERAL VIEW

The Petty Creek Road structure at milepost 0.9 was originally constructed in 1964. The three-span bridge is 456.9-feet in length and 27.9-feet wide. The structure is a continuous span steel two girder system with truss floorbeams and a concrete deck. The cast-in-place concrete deck is showing signs of deterioration and has a condition rating of 5 (Fair) as of the 2023 Montana Department of Transportation (MDT) bridge inspection. Inspections note the presence of delaminations, spalls, and transverse cracking in the concrete bridge deck. The inspection report noted the following repair suggestions; remove debris identified underwater at Bent 3, remove debris on bearings, remove debris on girders, cut trees and brush impacting bridge, repair deck spalls, and remove debris from bridge deck.

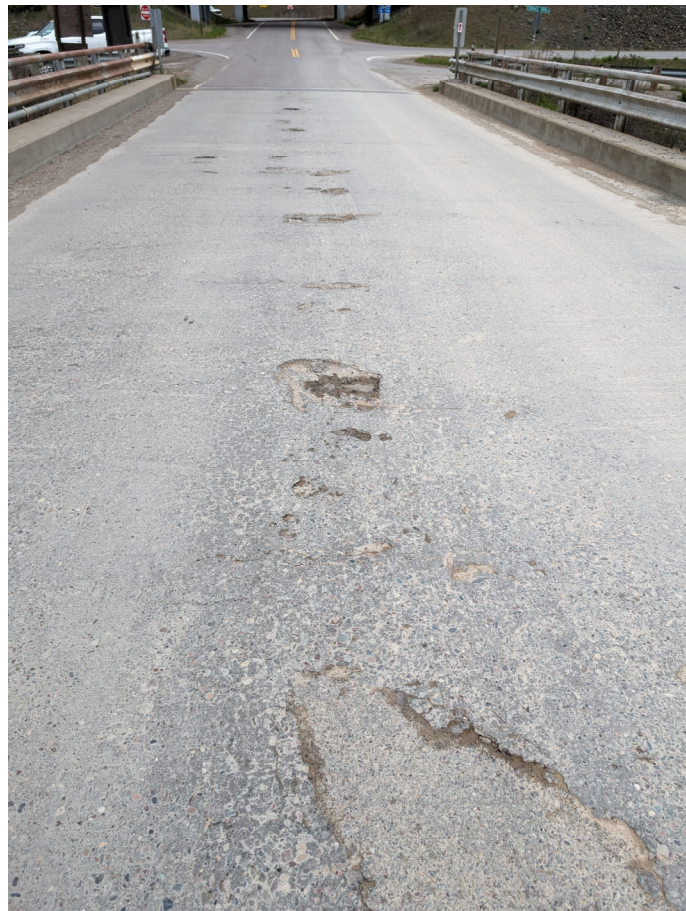
FIGURE 3: PETTY CREEK ROAD BRIDGE DECK

A field visit conducted by Morrison Maierle confirmed these deficiencies and Morrison Maierle recommends making these repairs. Overall, the structure appears to be performing well and the main structural deficiency is the concrete deck. The 2023 MDT bridge inspection noted the following in the deck:

- 28 square feet of spalls with 3 square feet of exposed rebar and 8 square feet of unsound patches
- 1,531 square feet of delaminations
- Abrasion/wear in wheel paths
- 480 square feet of developing jump cracks
- Full depth cracks in the soffit of span 1 every 5 feet

The recommended repair is to mill and overlay the existing concrete deck. While it has a higher cost than performing localized repairs it also has multiple benefits, such as, a smoother riding surface, better protection for long term service life, removes concrete that may have chloride penetration, repairs abrasion and wear in wheel paths, and it is more visually appealing to users. Full deck replacement is not warranted currently. Chloride sampling and detailed surface inspection of the deck would help determine if mill and overlay is more suitable than localized repairs and would provide guidance for mill and overlay depths.
