# Geotechnical Engineering Report

**Big Flat Road Review**  
**Missoula County, Montana**  
May 17, 2017  
Terracon Project No. C4165060

Re: Geotechnical Engineering Report  
Big Flat Road Review  
Missoula County, Montana  
Terracon Project No. C4165060

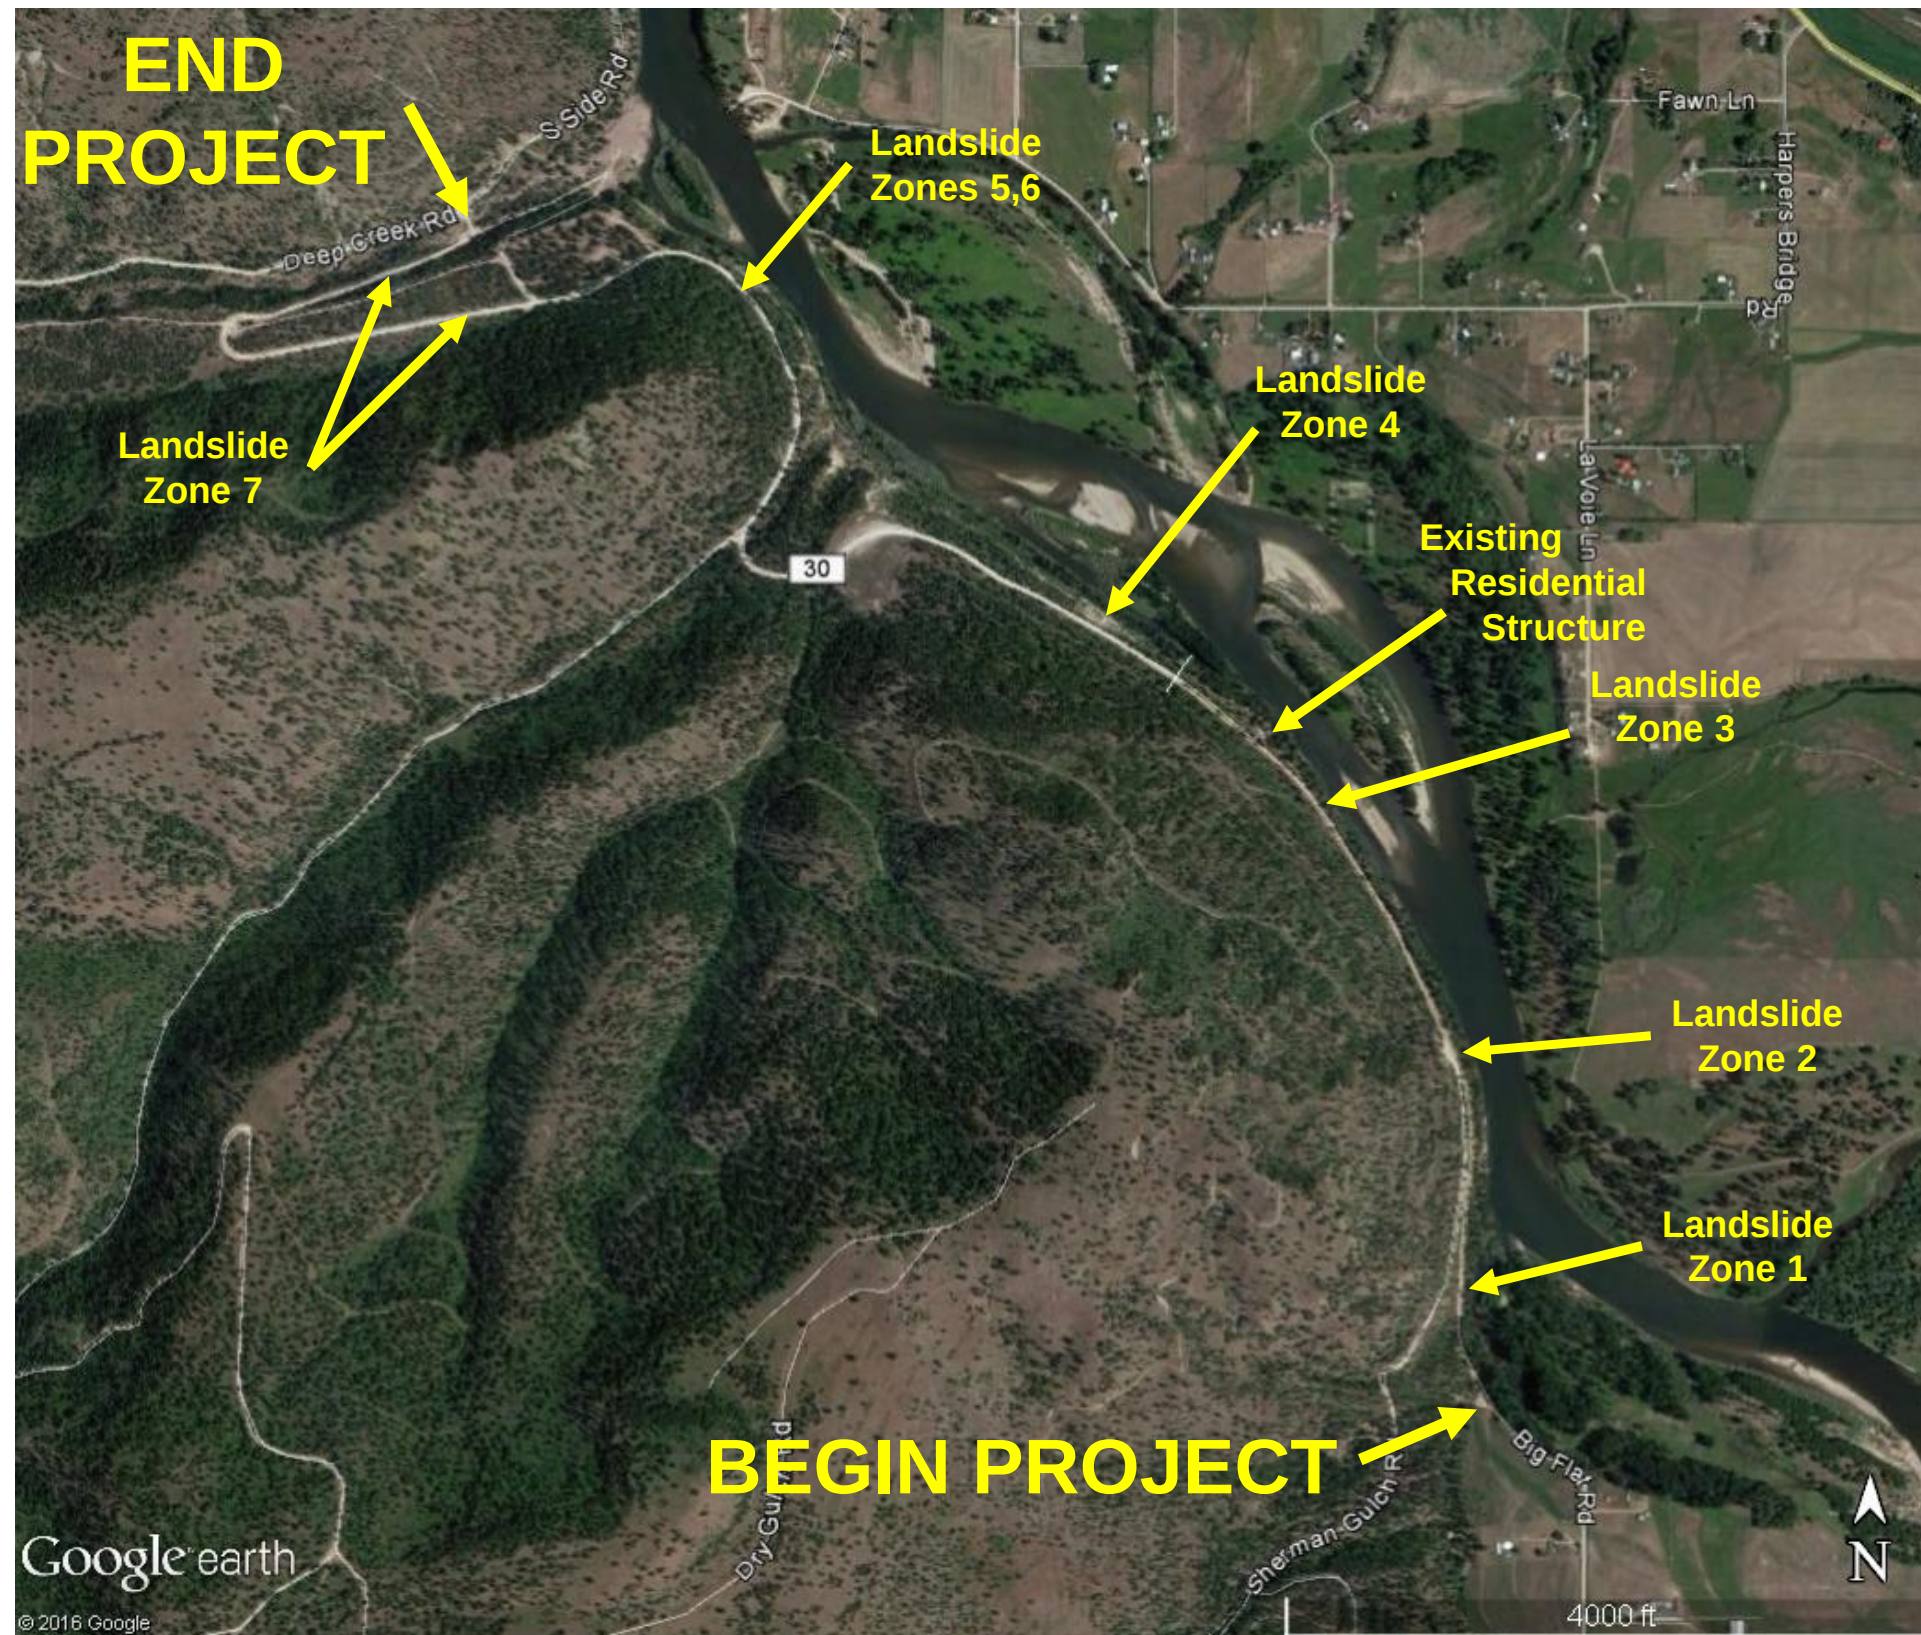
**April 7, 2006 Photo of Landslide Zone #1. The upper edge of the scarp extends approximately 8 feet into the road from the crest of the slope. At this time, the scarp extends about 45 feet along the slope crest. This slide was repaired but would continue to periodically fail, including a March 2017 failure (see Exhibit A-4)**
